# Access Compliance Report

## Public Rights-of-Way

### (Curb Ramps)

| Intersection ID: 10032531 | Main Street: N_COLLEGE_ST | Cross Street: N/A | Location: W |

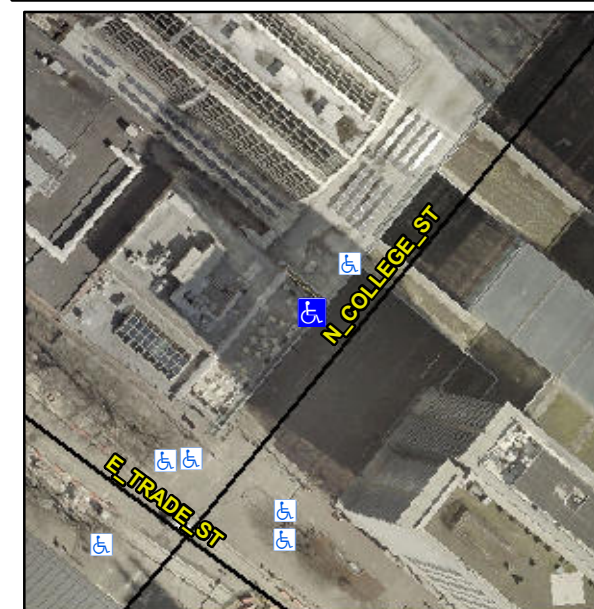
| ADA ID: 3006B6BC8260 | Ramp Type: PerpDiag | Initial Pass/Fail: Fail | Overall Compliance: No |
| Severity Score: 12.5 | | | |

**Not Found, R304.2.2**

| Compliance | Description | Data | Compliance | Description | Data |
|---|---|---|---|---|---|
| N/A | Ramp Length (in) | 49.0 | No | Ramp Slope (%) | 9.3 |
| Yes | Ramp Width (in) | 48.0 | Yes | Ramp XSlope (%) | 1.1 |

**Remove & Replace Curb Ramp With Two New Directional Ramps or Equivalent.**

Total Cost: \$ 3200.00
