Access Compliance Report Public Rights-of-Way (Curb Ramps)

Intersection ID: 5514 Main Street: SUNSET RD **Cross Street: MILHAVEN LN** Location: NE Ramp Type: Directional1 Initial Pass/Fail: Pass **Overall Compliance: No** 15 ADA ID: 300F04E5A21D **Severity Score:**

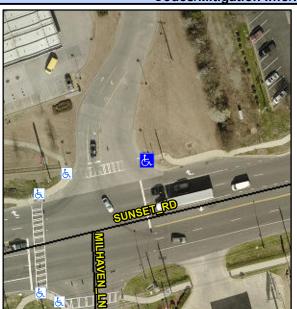
, ,,,,,,,,,,,,,,,,,,,,,,,,,,,,,,,,,,,,,			· ·			` ,
		Yes	Gutter Ponding?	No	Yes	Gutter Slope (%)
		No	Gutter Lip Ht (in)	0.3	Yes	Gutter X Slope (%)
		N/A	Painted X Walk1?	Yes		Road Slope (%)
			X Walk 1 Direction	To W		Road X Slope (%)
			X Walk 1 Width (in)	106.0	l	Clear Space?
			X Walk 1 Slope (%)	0.7	N/A	Clear Space to XWalk (in)
			X Walk 1 X Slope (%)	1.1	Yes	Storm Grate/Utility Hazard?
		Yes	Ramp inside XWalk1?	Yes		Storm Grate/Utility Type
		Yes	Any Obstructions?	No		
Total Cost:	\$ 1800.00		Obstruction Type		Yes	Surface Condition? (G/P)
				N/A	N/A	Curb Slope (%)

Possible Solutions:	<u>Co</u>
Remove & Replace Entire Ramp.	N/A
Grind Gutter Lip.	Yes
	Yes
	Yes
	No
	N/A
Surveyor Notes:	N/A
N/A	Yes
	Yes
	Yes
	Yes
PROW/ADA:	N/A
R304.2.3, R305.1.4, R302.7.2	N/A
	Yes
	No
	N/A
