Access Compliance Report

Public Rights-of-Way

(Curb Ramps)

Intersection ID: 9598	Main Street: FRANK_DR	Cross Street: THE_PLAZA	Location:	NE
ADA ID: 301402EAE5ED	Ramp Type: Perp	Initial Pass/Fail: Fail	Overall Compliance: No	Severity Score: 10
Codes/Mitigation Info/Possible Solution		Field Measurements/Component Compliance

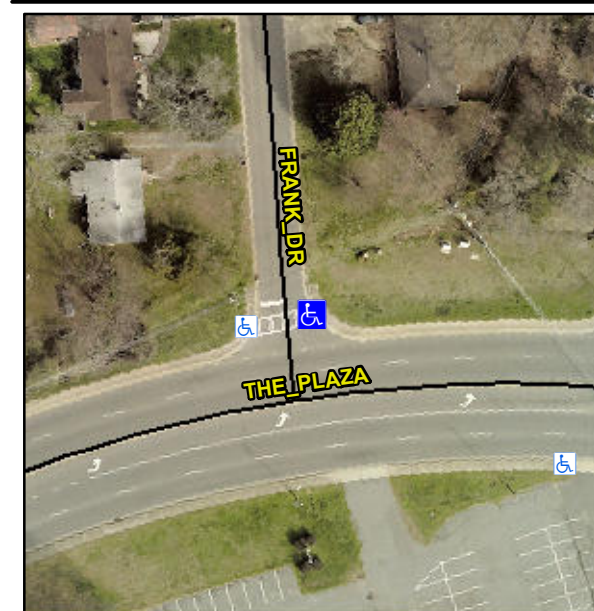
Not Found, R304.5.1, R304.5.3

Compliance	Description	Data	Compliance	Description	Data
N/A	Ramp Length (in)	62.0	Yes	Ramp Slope (%)	8.2
No	Ramp Width (in)	47.5	No	Ramp XSlope (%)	3.9
N/A	Flare Type LT	N/A	N/A	Flare Type RT	N/A
N/A	Flare Slope LT (%)	N/A	N/A	Flare Slope RT (%)	N/A
N/A	Flare Traversable LT?	N/A	N/A	Flare Traversable RT?	N/A
N/A	Landing Length (in)	N/A	N/A	DWS Provided?	N/A
N/A	Landing Width (in)	N/A	N/A	DWS Contrast?	N/A
N/A	Landing Slope (%)	N/A	N/A	DWS Length (in)	N/A
N/A	Landing X Slope (%)	N/A	N/A	DWS Full Width?	N/A
N/A	Landing Curb? (Y/N)	N/A	N/A	DWS Offset (in)	N/A
N/A	Shared Landing?	N/A			
N/A	Gutter Ponding?	N/A	N/A	Gutter Slope (%)	N/A
N/A	Gutter Lip Ht (in)	N/A	N/A	Gutter X Slope (%)	N/A
N/A	Painted X Walk1?	Yes	N/A	Painted X Walk2?	N/A
	X Walk 1 Direction	To W		X Walk 2 Direction	N/A
N/A	X Walk 1 Width (in)	87.0	N/A	X Walk 2 Width (in)	N/A
	X Walk 1 Slope (%)	2.7		X Walk 2 Slope (%)	N/A
	X Walk 1 X Slope (%)	2.4		X Walk 2 X Slope (%)	N/A

N/A	Ramp inside XWalk1?	Yes	N/A	Ramp inside XWalk2?	N/A
	Road Slope (%)	N/A	N/A	Clear Space?	N/A
	Road X Slope (%)	N/A	N/A	Clear Space to XWalk (in)	N/A
N/A	Any Obstructions?	N/A	N/A	Storm Grate/Utility Hazard?	N/A
	Obstruction Type			Storm Grate/Utility Type	
		N/A			N/A
		Yes		Surface Condition? (G/P)	Good

Possible Solutions:

Remove & Replace Entire Ramp.

Total Cost: \$ 1850.00
