Access Compliance Report

Public Rights-of-Way

(Curb Ramps)

Intersection ID: 14078	Main Street: EAST_BV	Cross Street: SOUTH_BV	Location:	N
ADA ID: 30385719858D	Ramp Type: Perp	Initial Pass/Fail: Fail	Overall Compliance: No	Severity Score: 25
Codes/Mitigation Info/Possible Solution		Field Measurements/Component Compliance

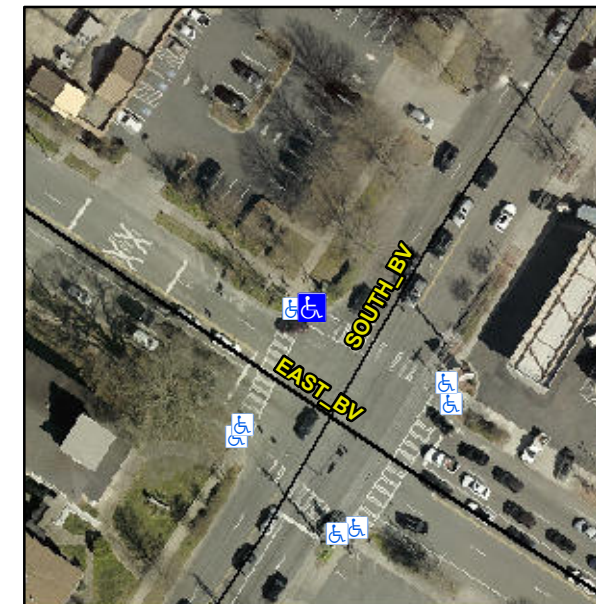
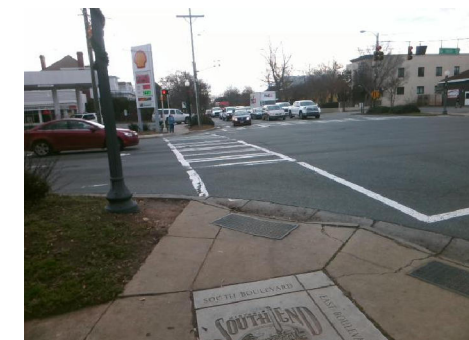
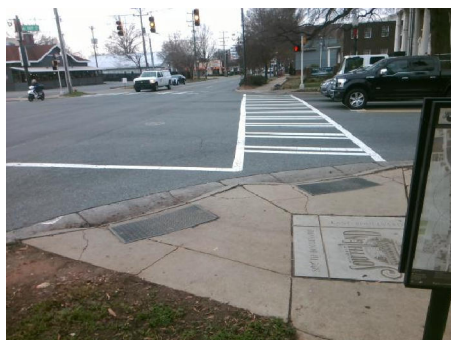
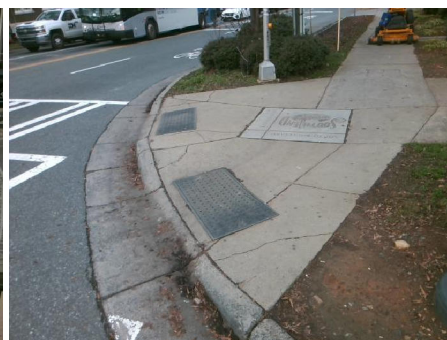
Not Found, R304.5.3

Compliance	Description	Data	Compliance	Description	Data
N/A	Ramp Length (in)	43.0	Yes	Ramp Slope (%)	5.2
Yes	Ramp Width (in)	48.0	No	Ramp XSlope (%)	8.9
N/A	Flare Type LT	N/A	N/A	Flare Type RT	N/A
N/A	Flare Slope LT (%)	N/A	N/A	Flare Slope RT (%)	N/A
N/A	Flare Traversable LT?	N/A	N/A	Flare Traversable RT?	N/A
N/A	Landing Length (in)	N/A	N/A	DWS Provided?	N/A
N/A	Landing Width (in)	N/A	N/A	DWS Contrast?	N/A
N/A	Landing Slope (%)	N/A	N/A	DWS Length (in)	N/A
N/A	Landing X Slope (%)	N/A	N/A	DWS Full Width?	N/A
N/A	Landing Curb? (Y/N)	N/A	N/A	DWS Offset (in)	N/A
N/A	Shared Landing?	N/A			
N/A	Gutter Ponding?	N/A	N/A	Gutter Slope (%)	N/A
N/A	Gutter Lip Ht (in)	N/A	N/A	Gutter X Slope (%)	N/A
N/A	Painted X Walk1?	Yes	N/A	Painted X Walk2?	N/A
	X Walk 1 Direction	To SE		X Walk 2 Direction	N/A
N/A	X Walk 1 Width (in)	109.0	N/A	X Walk 2 Width (in)	N/A
	X Walk 1 Slope (%)	6.4		X Walk 2 Slope (%)	N/A
	X Walk 1 X Slope (%)	1.0		X Walk 2 X Slope (%)	N/A

N/A	Ramp inside XWalk1?	Yes	N/A	Ramp inside XWalk2?	N/A
	Road Slope (%)	N/A	N/A	Clear Space?	N/A
	Road X Slope (%)	N/A	N/A	Clear Space to XWalk (in)	N/A
N/A	Any Obstructions?	N/A	N/A	Storm Grate/Utility Hazard?	N/A
	Obstruction Type			Storm Grate/Utility Type	
		N/A			N/A
		Yes		Surface Condition? (G/P)	Good

Possible Solutions:

Remove & Replace Entire Ramp.
