Access Compliance Report Public Rights-of-Way (Curb Ramps)

Intersection ID: 11431 Main Street: N_GRAHAM_ST Cross Street: W_9TH_ST Location:

ADA ID: 303D3030F9D7 Ramp Type: PerpDiag Initial Pass/Fail: Fail Overall Compliance: No Severity Score: 13.75

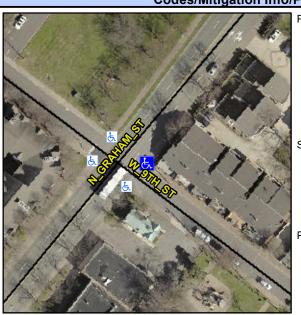
Not Found, R304.2.2, R304.5.3

Compliance Description		Data	Compliance		Description	Data
N/A	Ramp Length (in)	55.0	No	Ramp	Slope (%)	9.4
Yes	Ramp Width (in)	48.0	No	Ramp	XSlope (%)	2.8
N/A	Flare Type LT	N/A	N/A	Flare	Type RT	N/A
N/A	Flare Slope LT (%)	N/A	N/A	Flare	Slope RT (%)	N/A
N/A	Flare Traversable LT?	N/A	N/A	Flare	Traversable RT?	N/A
N/A	Landing Length (in)	N/A	N/A	DWS	Provided?	N/A
N/A	Landing Width (in)	N/A	N/A	DWS	Contrast?	N/A
N/A	Landing Slope (%)	N/A	N/A	DWS	Length (in)	N/A
N/A	Landing X Slope (%)	N/A	N/A	DWS	Full Width?	N/A
N/A	Landing Curb? (Y/N)	N/A	N/A	DWS	Offset (in)	N/A
N/A	Shared Landing?	N/A				
N/A	Gutter Ponding?	N/A	N/A	Gutte	r Slope (%)	N/A
N/A	Gutter Lip Ht (in)	N/A	N/A	Gutte	r X Slope (%)	N/A
N/A	Painted X Walk1?	No	N/A	Painte	ed X Walk2?	No
	X Walk 1 Direction	To NW		X Wa	lk 2 Direction	To SW
N/A	X Walk 1 Width (in)	N/A	N/A	X Wa	lk 2 Width (in)	N/A
	X Walk 1 Slope (%)	0.8		X Wa	lk 2 Slope (%)	2.0
	X Walk 1 X Slope (%)	1.8		X Wa	lk 2 X Slope (%)	0.1

N/A	Ramp inside XWalk1?	N/A	N/A	Ramp	inside XWalk2?	N/A
	Road Slope (%)	0.6	N/A	Clear	Space?	N/A
	Road X Slope (%)	4.2	N/A	Clear	Space to XWalk (in)	N/A
N/A	Any Obstructions?	N/A	N/A	Storm	Grate/Utility Hazard?	N/A
	Obstruction Type		l	Storm	Grate/Utility Type	
		N/A				N/A

Remove & Replace Curb Ramp With
Two New Directional Ramps or
Equivalent.
