# Access Compliance Report

## Public Rights-of-Way

### (Curb Ramps)

Intersection ID: 10017106	Main Street: CENTRAL_AV	Cross Street: N/A	Location: NW
ADA ID: 3042A5A50EB8	Ramp Type: ParaDiag	Initial Pass/Fail: Fail	Overall Compliance: No
Codes/Mitigation Info/Possible Solution		Field Measurements/Component Compliance

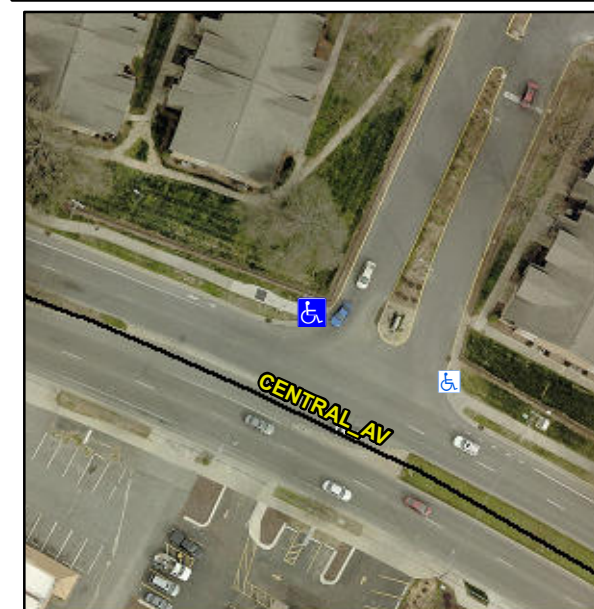
**MEDIAN ACROSS CENTRAL AV**

**R304.3.2, R304.5.3**

Compliance	Description	Data	Compliance	Description	Data
N/A	Ramp Length LT (in)	24.0	N/A	Ramp Length RT (in)	57.0
Yes	Ramp Width LT (in)	77.0	Yes	Ramp Width RT (in)	73.0
Yes	Ramp Slope LT (%)	3.5	No	Ramp Slope RT (%)	8.5
Yes	Ramp XSlope LT (%)	1.2	No	Ramp XSlope RT (%)	2.4
N/A	Landing Length (in)	N/A	N/A	DWS Provided?	N/A
N/A	Landing Width (in)	N/A	N/A	DWS Contrast?	N/A
N/A	Landing Slope (%)	N/A	N/A	DWS Length (in)	N/A
N/A	Landing X Slope (%)	N/A	N/A	DWS Full Width?	N/A
N/A	Landing Curb? (Y/N)	N/A	N/A	DWS Offset (in)	N/A
N/A	Shared Landing?	N/A			
N/A	Gutter Ponding?	N/A	N/A	Gutter Slope (%)	N/A
N/A	Gutter Lip Ht (in)	N/A	N/A	Gutter X Slope (%)	N/A
N/A	Painted X Walk1?	No	N/A	Painted X Walk2?	No
	X Walk 1 Direction	To SW		X Walk 2 Direction	To SE
N/A	X Walk 1 Width (in)	N/A	N/A	X Walk 2 Width (in)	N/A
	X Walk 1 Slope (%)	0.3		X Walk 2 Slope (%)	1.1
	X Walk 1 X Slope (%)	0.3		X Walk 2 X Slope (%)	1.8
N/A	Ramp inside XWalk1?	N/A	N/A	Ramp inside XWalk2?	N/A

Road Slope (%)	0.5	N/A	Clear Space?	N/A
	Road X Slope (%)	3.0	N/A	Clear Space to XWalk (in)	N/A
N/A	Any Obstructions?	N/A	N/A	Storm Grate/Utility Hazard?	N/A
	Obstruction Type			Storm Grate/Utility Type	
		N/A			N/A
			Yes	Surface Condition? (G/P)	Good
			N/A	Curb Slope (%)	3.6

**Remove & Replace Curb Ramp With Two New Directional Ramps or Equivalent.**
