Access Compliance Report Public Rights-of-Way (Curb Ramps)

Main Street: WILLOW_GREEN_PL Intersection ID: 52443 Cross Street: BENDING_BIRCH_PL Location: SE **ADA ID: 3042B73E1FED** Ramp Type: Perp Initial Pass/Fail: Fail **Overall Compliance: No Severity Score:** 12.5

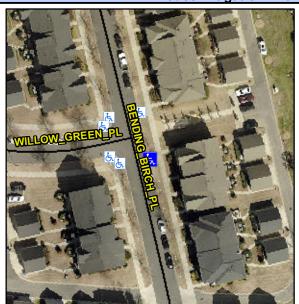
Field Measurements/Component Compliance									
Comp	liance Description	Data	Comp	liance	Description	Data			
N/A	Ramp Length (in)	94.0	No	Ramp	Slope (%)	9.9			
Yes	Ramp Width (in)	71.5	Yes	Ramp	XSlope (%)	0.9			
N/A	Flare Type LT	N/A	N/A	Flare	Type RT	N/A			
N/A	Flare Slope LT (%)	N/A	N/A	Flare	Slope RT (%)	N/A			
N/A	Flare Traversable LT?	N/A	N/A	Flare	Traversable RT?	N/A			
N/A	Landing Length (in)	N/A	N/A	DWS	Provided?	N/A			
N/A	Landing Width (in)	N/A	N/A	DWS	Contrast?	N/A			
N/A	Landing Slope (%)	N/A	N/A	DWS	Length (in)	N/A			
N/A	Landing X Slope (%)	N/A	N/A	DWS	Full Width?	N/A			
N/A	Landing Curb? (Y/N)	N/A	N/A	DWS	Offset (in)	N/A			
N/A	Shared Landing?	N/A							
N/A	Gutter Ponding?	N/A	N/A	Gutte	r Slope (%)	N/A			
N/A	Gutter Lip Ht (in)	N/A	N/A	Gutte	r X Slope (%)	N/A			
N/A	Painted X Walk1?	No	N/A	Paint	ed X Walk2?	N/A			
	X Walk 1 Direction	To W		X Wa	lk 2 Direction	N/A			
N/A	X Walk 1 Width (in)	N/A	N/A	X Wa	lk 2 Width (in)	N/A

X Walk 1 Slope (%)	2.3		X Wa	lk 2 Slope (%)	N/A			
	X Walk 1 X Slope (%)	1.6		X Wa	lk 2 X Slope (%)	N/A			
N/A	Ramp inside XWalk1?	N/A	N/A	Ramp	inside XWalk2?	N/A			
	Road Slope (%)	N/A	N/A	Clear	Space?	N/A			
	Road X Slope (%)	N/A	N/A	Clear	Space to XWalk (in)	N/A			
N/A	Any Obstructions?	N/A	N/A	Storm	n Grate/Utility Hazard?	N/A			
	Obstruction Type			Storm	Grate/Utility Type				
		N/A				N/A			
			Yes	Surfa	ce Condition? (G/P)	Good

Surveyor Notes:			N/A
N/A			N/A
			N/A
			N/A
			N/A
PROW/ADA:			N/A
R304.2.2			N/A
			N/A
			N/A
			N/A
5441 O-44	\$ 1850.0 0	N/A	
Total Cost:	\$	1050.00
