Access Compliance Report

Public Rights-of-Way

(Curb Ramps)

Intersection ID: 52988	Main Street: LANDING_PLACE_LN	Cross Street: GREYTHORNE_DR	Location: NW
ADA ID: 304C6D8E49FC	Ramp Type: BlendTrans1	Initial Pass/Fail: Fail	Overall Compliance: No
		Severity Score: 12.5

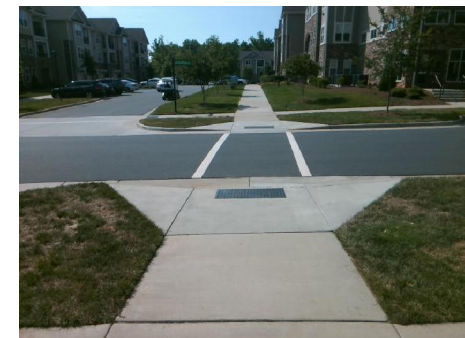
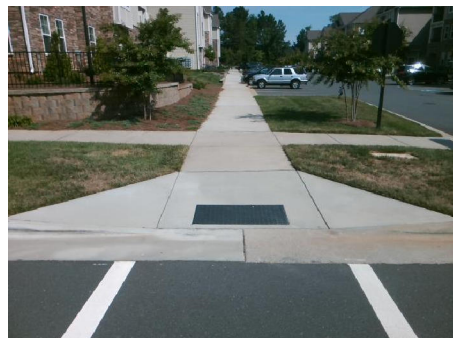
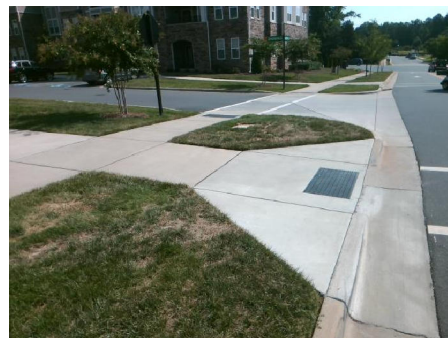
Not Found, R304.5.3

Compliance	Description	Data	Compliance	Description	Data
N/A	Ramp Length (in)	87.0	Yes	BlendTrans Slope (%)	4.5
Yes	Ramp Width (in)	83.0	No	BlendTrans XSlope (%)	5.2
N/A	Flare Type LT	N/A	N/A	Flare Type RT	N/A
N/A	Flare Slope LT (%)	N/A	N/A	Flare Slope RT (%)	N/A
N/A	Flare Traversable LT?	N/A	N/A	Flare Traversable RT?	N/A
N/A	Landing Length (in)	N/A	N/A	DWS Provided?	N/A
N/A	Landing Width (in)	N/A	N/A	DWS Contrast?	N/A
N/A	Landing Slope (%)	N/A	N/A	DWS Length (in)	N/A
N/A	Landing X Slope (%)	N/A	N/A	DWS Full Width?	N/A
N/A	Landing Curb? (Y/N)	N/A	N/A	DWS Offset (in)	N/A
N/A	Shared Landing?	N/A			
N/A	Gutter Ponding?	N/A	N/A	Gutter Slope (%)	N/A
N/A	Gutter Lip Ht (in)	N/A	N/A	Gutter X Slope (%)	N/A
N/A	Painted X Walk1?	Yes	N/A	Painted X Walk2?	N/A
	X Walk 1 Direction	To SE		X Walk 2 Direction	N/A
	X Walk 1 Width (in)	82.0		X Walk 2 Width (in)	N/A
	X Walk 1 Slope (%)	2.5		X Walk 2 Slope (%)	N/A
	X Walk 1 X Slope (%)	3.1		X Walk 2 X Slope (%)	N/A

N/A	Ramp inside XWalk1?	Yes	N/A	Ramp inside XWalk2?	N/A
	Road Slope (%)	3.1		Clear Space?	N/A
	Road X Slope (%)	2.5	N/A	Clear Space to XWalk (in)	N/A
N/A	Any Obstructions?	N/A	N/A	Storm Grate/Utility Hazard?	N/A
	Obstruction Type			Storm Grate/Utility Type	
		N/A			N/A
			Yes	Surface Condition? (G/P)	Good
			No	Curb Slope (%)	14.9

Remove & Replace Curb Ramp With Two New Directional Ramps or Equivalent.

Total Cost: \$ 3200.00
