Access Compliance Report Public Rights-of-Way (Curb Ramps)

Intersection ID: 29370 Main Street: SAM_WILSON_RD Cross Street: WILSON_GLEN_DR Location: SE

ADA ID: 304F956543B1 Ramp Type: Perp Initial Pass/Fail: Fail Overall Compliance: No Severity Score: 22.5

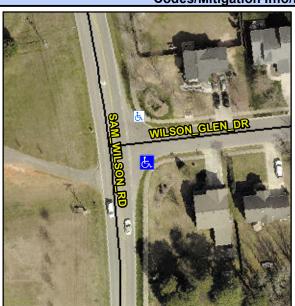
Field Measurements/Component Compliance						
Comp	liance Description	Data	Comp	liance Description	Data	
N/A	Ramp Length (in)	47.0	No	Ramp Slope (%)	10.8	
No	Ramp Width (in)	39.0	No	Ramp XSlope (%)	2.7	
N/A	Flare Type LT	N/A	N/A	Flare Type RT	N/A	
N/A	Flare Slope LT (%)	N/A	N/A	Flare Slope RT (%)	N/A	
N/A	Flare Traversable LT?	N/A	N/A	Flare Traversable RT?	N/A	
N/A	Landing Length (in)	N/A	N/A	DWS Provided?	N/A	
N/A	Landing Width (in)	N/A	N/A	DWS Contrast?	N/A	
N/A	Landing Slope (%)	N/A	N/A	DWS Length (in)	N/A	
N/A	Landing X Slope (%)	N/A	N/A	DWS Full Width?	N/A	
N/A	Landing Curb? (Y/N)	N/A	N/A	DWS Offset (in)	N/A	
N/A	Shared Landing?	N/A				
N/A	Gutter Ponding?	N/A	N/A	Gutter Slope (%)	N/A	
N/A	Gutter Lip Ht (in)	N/A	N/A	Gutter X Slope (%)	N/A	
N/A	Painted X Walk1?	No	N/A	Painted X Walk2?	N/A	
	X Walk 1 Direction	To N		X Walk 2 Direction	N/A	
N/A	X Walk 1 Width (in)	N/A	N/A	X Walk 2 Width (in)	N/A	
	X Walk 1 Slope (%)	1.2		X Walk 2 Slope (%)	N/A

X Walk 1 X Slope (%)	0.3		X Walk 2 X Slope (%)	N/A	
N/A	Ramp inside XWalk1?	N/A	N/A	Ramp inside XWalk2?	N/A	
	Road Slope (%)	N/A	N/A	Clear Space?	N/A	
	Road X Slope (%)	N/A	N/A	Clear Space to XWalk (in)	N/A	
N/A	Any Obstructions?	N/A	N/A	Storm Grate/Utility Hazard?	N/A	
	Obstruction Type			Storm Grate/Utility Type		
		N/A			N/A	
			Yes	Surface Condition? (G/P)	Good	
1

Possible Solutions:	9		
Remove & Replace Entire Ramp.			
	N		
	N		
	N		
	N		
	N		
Surveyor Notes:	N		
N/A	N		
	N		
	N		
	N		
PROW/ADA:	N		
R304.5.1, R304.2.2, R304.5.3	N		
	N		
	N

Total Cost: \$ 1850.00
