Access Compliance Report

Public Rights-of-Way

(Curb Ramps)

Intersection ID: N/A	Main Street: S COLLEGE ST	Cross Street: HILL ST	Location: N
ADA ID: 3050DE0E4A74	Ramp Type: Para	Initial Pass/Fail: Pass	Overall Compliance: No
Codes/Mitigation Info/Possible Solution		Field Measurements/Component Compliance	
Severity Score: 0.25

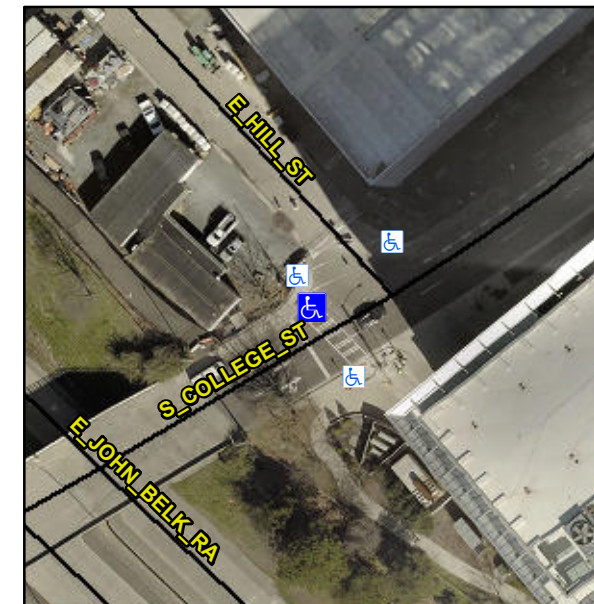
Compliance	Description	Data	Compliance	Description	Data
N/A	Ramp Length LT (in)	170.0	N/A	Ramp Length RT (in)	51.0
Yes	Ramp Width LT (in)	61.0	Yes	Ramp Width RT (in)	61.0
Yes	Ramp Slope LT (%)	7.8	Yes	Ramp Slope RT (%)	7.6
No	Ramp XSlope LT (%)	3.0	Yes	Ramp XSlope RT (%)	1.4
Yes	Landing Length (in)	61.0	Yes	DWS Provided?	Yes
Yes	Landing Width (in)	59.0	Yes	DWS Contrast?	Yes
No	Landing Slope (%)	2.9	Yes	DWS Length (in)	24.0
Yes	Landing X Slope (%)	4.8	Yes	DWS Full Width?	Yes
N/A	Landing Curb? (Y/N)	Yes	Yes	DWS Offset (in)	0.0
N/A	Shared Landing?	No			
Yes	Gutter Ponding?	No	Yes	Gutter Slope (%)	3.8
Yes	Gutter Lip Ht (in)	0.0	No	Gutter X Slope (%)	5.4
N/A	Painted X Walk1?	Yes	N/A	Painted X Walk2?	N/A
	X Walk 1 Direction	To SE		X Walk 2 Direction	N/A
N/A	X Walk 1 Width (in)	104.0	N/A	X Walk 2 Width (in)	N/A
	X Walk 1 Slope (%)	0.4		X Walk 2 Slope (%)	N/A
	X Walk 1 X Slope (%)	5.3		X Walk 2 X Slope (%)	N/A
Yes	Ramp inside XWalk1?	Yes	N/A	Ramp inside XWalk2?	N/A

Road Slope (%)	N/A	N/A	Clear Space?	Yes
	Road X Slope (%)	N/A	N/A	Clear Space to XWalk (in)	N/A
Yes	Any Obstructions?	No	Yes	Storm Grate/Utility Hazard?	No
	Obstruction Type			Storm Grate/Utility Type	
		N/A			N/A
			Yes	Surface Condition? (G/P)	Good
			N/A	Curb Slope (%)	2.9

Possible Solutions:

**Remove & Replace Entire Ramp.
Remove & Replace Gutter.**

**R304.5.3, R304.2.2-Perp, R304.3.2-
Para**
