Access Compliance Report

Public Rights-of-Way

(Curb Ramps)

Intersection ID: 50928	Main Street: GREAT_FUTURE_DR	Cross Street: MARVIN_RD	Location: NW
ADA ID: 30560D471416	Ramp Type: Perp	Initial Pass/Fail: Fail	Overall Compliance: No
Severity Score: 12.5			
Codes/Mitigation Info/Possible Solution		Field Measurements/Component Compliance

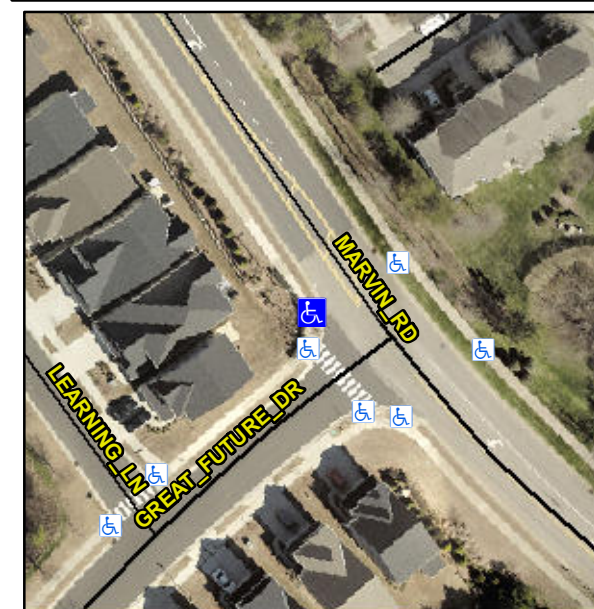
Not Found, R304.5.3

Compliance	Description	Data	Compliance	Description	Data
N/A	Ramp Length (in)	46.0	Yes	Ramp Slope (%)	6.6
Yes	Ramp Width (in)	48.0	No	Ramp XSlope (%)	5.2
N/A	Flare Type LT	N/A	N/A	Flare Type RT	N/A
N/A	Flare Slope LT (%)	N/A	N/A	Flare Slope RT (%)	N/A
N/A	Flare Traversable LT?	N/A	N/A	Flare Traversable RT?	N/A
N/A	Landing Length (in)	N/A	N/A	DWS Provided?	N/A
N/A	Landing Width (in)	N/A	N/A	DWS Contrast?	N/A
N/A	Landing Slope (%)	N/A	N/A	DWS Length (in)	N/A
N/A	Landing X Slope (%)	N/A	N/A	DWS Full Width?	N/A
N/A	Landing Curb? (Y/N)	N/A	N/A	DWS Offset (in)	N/A
N/A	Shared Landing?	N/A			
N/A	Gutter Ponding?	N/A	N/A	Gutter Slope (%)	N/A
N/A	Gutter Lip Ht (in)	N/A	N/A	Gutter X Slope (%)	N/A
N/A	Painted X Walk1?	No	N/A	Painted X Walk2?	N/A
	X Walk 1 Direction	To NE		X Walk 2 Direction	N/A
N/A	X Walk 1 Width (in)	N/A	N/A	X Walk 2 Width (in)	N/A
	X Walk 1 Slope (%)	3.6		X Walk 2 Slope (%)	N/A
	X Walk 1 X Slope (%)	6.8		X Walk 2 X Slope (%)	N/A

N/A	Ramp inside XWalk1?	N/A	N/A	Ramp inside XWalk2?	N/A
	Road Slope (%)	N/A	N/A	Clear Space?	N/A
	Road X Slope (%)	N/A	N/A	Clear Space to XWalk (in)	N/A
N/A	Any Obstructions?	N/A	N/A	Storm Grate/Utility Hazard?	N/A
	Obstruction Type			Storm Grate/Utility Type	
		N/A			N/A
		Yes		Surface Condition? (G/P)	Good

Possible Solutions:

Remove & Replace Entire Ramp.

Total Cost: \$ 1850.00
