# Access Compliance Report

## Public Rights-of-Way

### (Curb Ramps)

| Intersection ID: 53971 | Main Street: BEREWICK_TOWN_CENTRE | Cross Street: CADEN_RD | Location: SE |

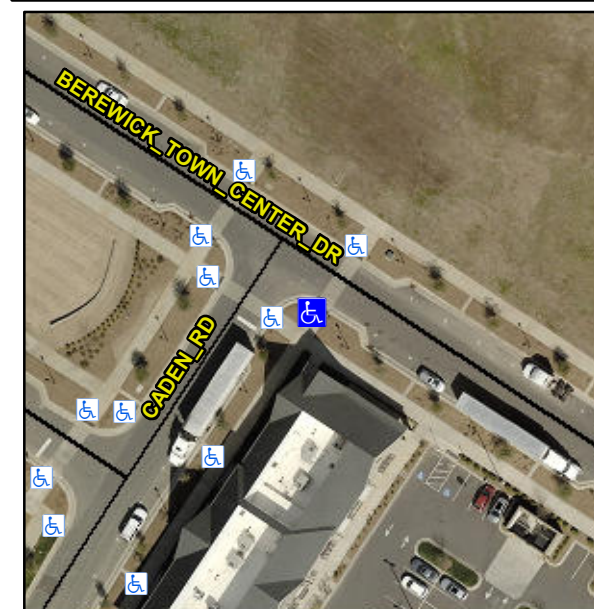
| ADA ID: 30692018C860 | Ramp Type: BlendTrans1 | Initial Pass/Fail: Pass | Overall Compliance: No |
| Severity Score: 0.25 | | | |

| Compliance | Description | Data | Compliance | Description | Data |
|---|---|---|---|---|---|
| Yes | Ramp Width (in) | 92.0 | No | BlendTrans XSlope (%) | 2.8 |
| No | Landing X Slope (%) | 2.9 | Yes | DWS Full Width? | Yes |
| N/A | Landing Curb? (Y/N) | No | No | DWS Offset (in) | 6.0 |

**Remove & Replace Curb Ramp With Two New Directional Ramps or Equivalent.**

**R304.5.3, R305.2**
