Access Compliance Report

Public Rights-of-Way

(Curb Ramps)

Intersection ID: 25141	Main Street: PINEVILLE-MATTHEWS_RD	Cross Street: RIDGELOCH_PL	Location: SW
ADA ID: 306F99DECD51	Ramp Type: Perp	Initial Pass/Fail: Fail	Overall Compliance: No
Severity Score: 22.5			
Codes/Mitigation Info/Possible Solution		Field Measurements/Component Compliance

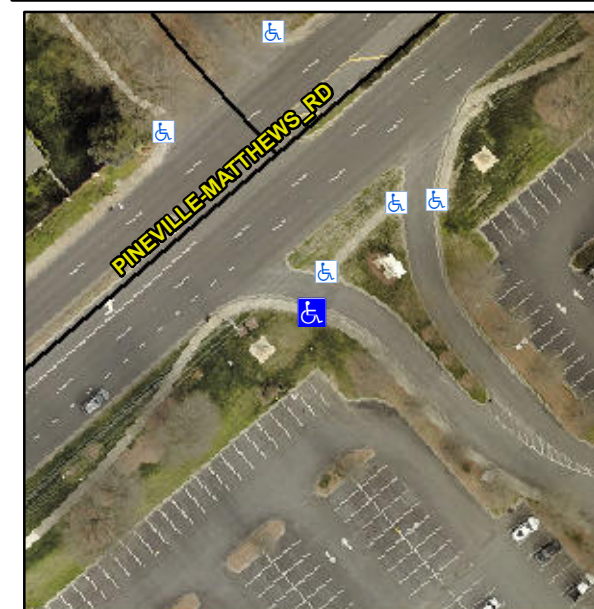
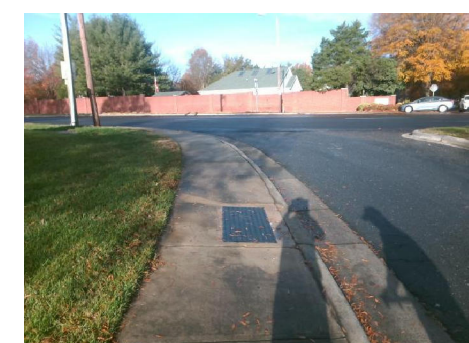
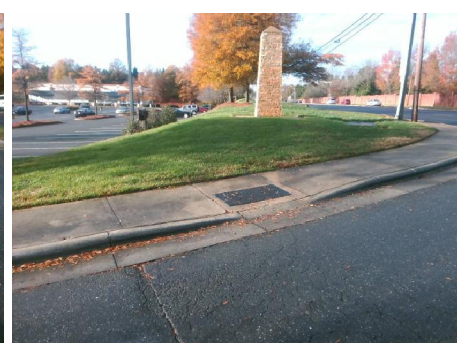
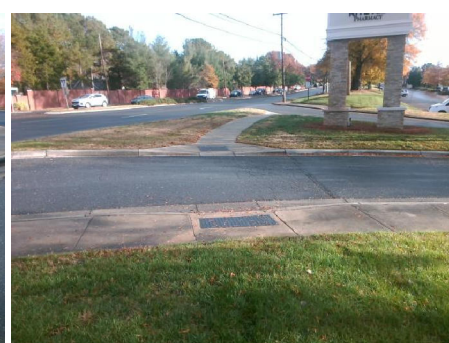
Not Found, R304.5.1, R304.2.2

Compliance	Description	Data	Compliance	Description	Data
N/A	Ramp Length (in)	59.5	No	Ramp Slope (%)	9.8
No	Ramp Width (in)	46.0	Yes	Ramp XSlope (%)	4.9
N/A	Flare Type LT	N/A	N/A	Flare Type RT	N/A
N/A	Flare Slope LT (%)	N/A	N/A	Flare Slope RT (%)	N/A
N/A	Flare Traversable LT?	N/A	N/A	Flare Traversable RT?	N/A
N/A	Landing Length (in)	N/A	N/A	DWS Provided?	N/A
N/A	Landing Width (in)	N/A	N/A	DWS Contrast?	N/A
N/A	Landing Slope (%)	N/A	N/A	DWS Length (in)	N/A
N/A	Landing X Slope (%)	N/A	N/A	DWS Full Width?	N/A
N/A	Landing Curb? (Y/N)	N/A	N/A	DWS Offset (in)	N/A
N/A	Shared Landing?	N/A			
N/A	Gutter Ponding?	N/A	N/A	Gutter Slope (%)	N/A
N/A	Gutter Lip Ht (in)	N/A	N/A	Gutter X Slope (%)	N/A
N/A	Painted X Walk1?	No	N/A	Painted X Walk2?	N/A
	X Walk 1 Direction	To NE		X Walk 2 Direction	N/A
N/A	X Walk 1 Width (in)	N/A	N/A	X Walk 2 Width (in)	N/A
	X Walk 1 Slope (%)	4.5		X Walk 2 Slope (%)	N/A
	X Walk 1 X Slope (%)	6.5		X Walk 2 X Slope (%)	N/A

N/A	Ramp inside XWalk1?	N/A	N/A	Ramp inside XWalk2?	N/A
	Road Slope (%)	N/A	N/A	Clear Space?	N/A
	Road X Slope (%)	N/A	N/A	Clear Space to XWalk (in)	N/A
N/A	Any Obstructions?	N/A	N/A	Storm Grate/Utility Hazard?	N/A
	Obstruction Type			Storm Grate/Utility Type	
		N/A			N/A
			Yes	Surface Condition? (G/P)	Good

Possible Solutions:

Remove & Replace Entire Ramp.

Total Cost: \$ 1850.00
