Access Compliance Report Public Rights-of-Way (Curb Ramps)

Intersection ID: N/A Main Street: SOUTH BV **Cross Street: TIFFANI LN** Location: SE Initial Pass/Fail: Fail **Overall Compliance: No Severity Score:** 12.5 ADA ID: 307A39BC4730 Ramp Type: PerpDiag

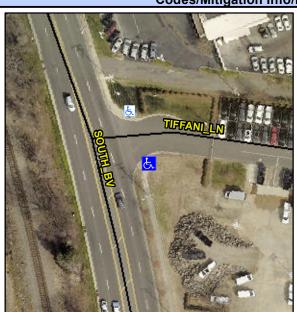
Street 1 Name TIFFANI LN Stop Condition-Street 2 **SOUTH BV** Street 2 Name Stop Condition-Street 1

Possible Solutions: Remove & Replace Curb Ramp With Two New Directional Ramps or Equivalent. Surveyor Notes: N/A PROW/ADA: R304.2.2
