Access Compliance Report

Public Rights-of-Way

(Curb Ramps)

Intersection ID: 5576	Main Street: BELLHAVEN_BV	Cross Street: COULWOOD_PARK_DR	Location: W
ADA ID: 307C8A55FF00	Ramp Type: Perp	Initial Pass/Fail: Fail	Overall Compliance: No
		Severity Score: 12.5

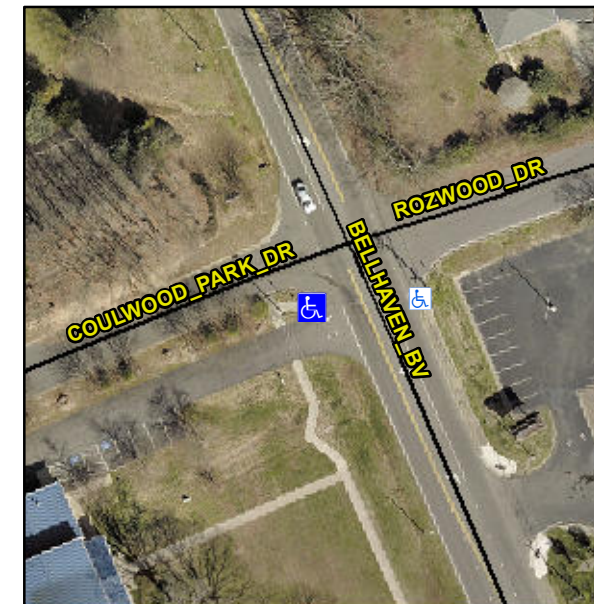
Not Found, R304.2.2

Compliance	Description	Data	Compliance	Description	Data
N/A	Ramp Length (in)	71.0	No	Ramp Slope (%)	8.9
Yes	Ramp Width (in)	48.0	Yes	Ramp XSlope (%)	0.9
N/A	Flare Type LT	N/A	N/A	Flare Type RT	N/A
N/A	Flare Slope LT (%)	N/A	N/A	Flare Slope RT (%)	N/A
N/A	Flare Traversable LT?	N/A	N/A	Flare Traversable RT?	N/A
N/A	Landing Length (in)	N/A	N/A	DWS Provided?	N/A
N/A	Landing Width (in)	N/A	N/A	DWS Contrast?	N/A
N/A	Landing Slope (%)	N/A	N/A	DWS Length (in)	N/A
N/A	Landing X Slope (%)	N/A	N/A	DWS Full Width?	N/A
N/A	Landing Curb? (Y/N)	N/A	N/A	DWS Offset (in)	N/A
N/A	Shared Landing?	N/A			
N/A	Gutter Ponding?	N/A	N/A	Gutter Slope (%)	N/A
N/A	Gutter Lip Ht (in)	0.5	N/A	Gutter X Slope (%)	N/A
N/A	Painted X Walk1?	No	N/A	Painted X Walk2?	N/A
	X Walk 1 Direction	To SE		X Walk 2 Direction	N/A
N/A	X Walk 1 Width (in)	N/A	N/A	X Walk 2 Width (in)	N/A
	X Walk 1 Slope (%)	0.4		X Walk 2 Slope (%)	N/A
	X Walk 1 X Slope (%)	2.5		X Walk 2 X Slope (%)	N/A

N/A	Ramp inside XWalk1?	N/A	N/A	Ramp inside XWalk2?	N/A
	Road Slope (%)	N/A	N/A	Clear Space?	N/A
	Road X Slope (%)	N/A	N/A	Clear Space to XWalk (in)	N/A
N/A	Any Obstructions?	N/A	N/A	Storm Grate/Utility Hazard?	N/A
	Obstruction Type			Storm Grate/Utility Type	
		N/A			N/A
			Yes	Surface Condition? (G/P)	Good

Remove & Replace Entire Ramp.
