Access Compliance Report

Public Rights-of-Way

(Curb Ramps)

Intersection ID: 49150	Main Street: VIDAL_LN	Cross Street: DACAVIN_DR	Location: W
ADA ID: 3088A05BFB4E	Ramp Type: PerpDiag	Initial Pass/Fail: Fail	Overall Compliance: No
Severity Score: 33.75			
Codes/Mitigation Info/Possible Solution		Field Measurements/Component Compliance

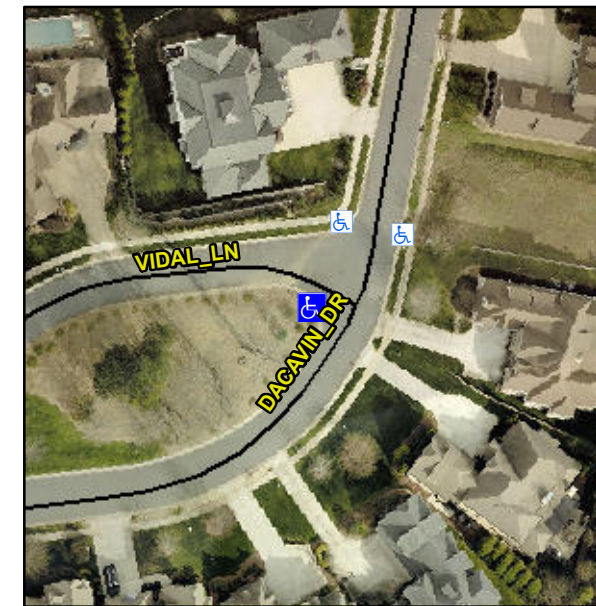
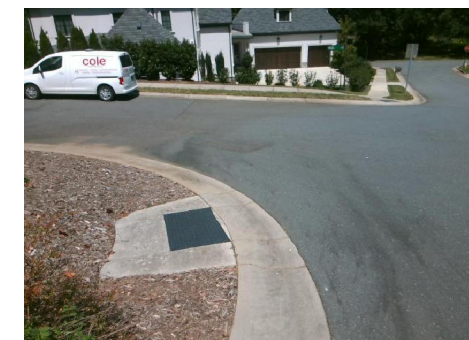
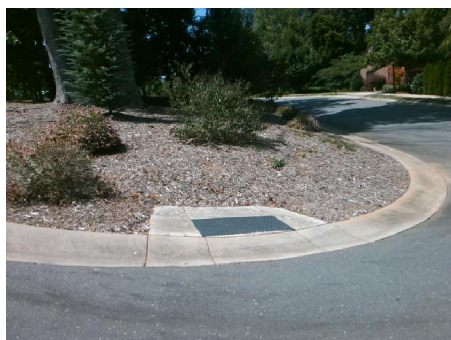
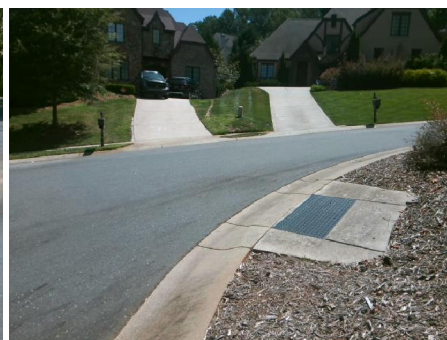
Not Found, R304.5.1, R304.5.3

Compliance	Description	Data	Compliance	Description	Data
N/A	Ramp Length (in)	48.0	Yes	Ramp Slope (%)	5.3
No	Ramp Width (in)	45.0	No	Ramp XSlope (%)	14.9
N/A	Flare Type LT	N/A	N/A	Flare Type RT	N/A
N/A	Flare Slope LT (%)	N/A	N/A	Flare Slope RT (%)	N/A
N/A	Flare Traversable LT?	N/A	N/A	Flare Traversable RT?	N/A
N/A	Landing Length (in)	N/A	N/A	DWS Provided?	N/A
N/A	Landing Width (in)	N/A	N/A	DWS Contrast?	N/A
N/A	Landing Slope (%)	N/A	N/A	DWS Length (in)	N/A
N/A	Landing X Slope (%)	N/A	N/A	DWS Full Width?	N/A
N/A	Landing Curb? (Y/N)	N/A	N/A	DWS Offset (in)	N/A
N/A	Shared Landing?	N/A			
N/A	Gutter Ponding?	N/A	N/A	Gutter Slope (%)	N/A
N/A	Gutter Lip Ht (in)	N/A	N/A	Gutter X Slope (%)	N/A
N/A	Painted X Walk1?	No	N/A	Painted X Walk2?	No
	X Walk 1 Direction	To E		X Walk 2 Direction	To NE
N/A	X Walk 1 Width (in)	N/A	N/A	X Walk 2 Width (in)	N/A
	X Walk 1 Slope (%)	3.9		X Walk 2 Slope (%)	13.2
	X Walk 1 X Slope (%)	16.3		X Walk 2 X Slope (%)	4.8

N/A	Ramp inside XWalk1?	N/A	N/A	Ramp inside XWalk2?	N/A
	Road Slope (%)	13.8	N/A	Clear Space?	N/A
	Road X Slope (%)	5.8	N/A	Clear Space to XWalk (in)	N/A
N/A	Any Obstructions?	N/A	N/A	Storm Grate/Utility Hazard?	N/A
	Obstruction Type			Storm Grate/Utility Type	
		N/A			N/A
		Yes		Surface Condition? (G/P)	Good

Possible Solutions:

Remove & Replace Curb Ramp With Two New Directional Ramps or Equivalent.
