Access Compliance Report

Public Rights-of-Way

(Curb Ramps)

Intersection ID: 19052	Main Street: COOPER_DR	Cross Street: TYVOLA_RD	Location:	N
ADA ID: 30890CD4111C	Ramp Type: PerpDiag	Initial Pass/Fail: Fail	Overall Compliance: No	Severity Score: 13.75
Codes/Mitigation Info/Possible Solution		Field Measurements/Component Compliance

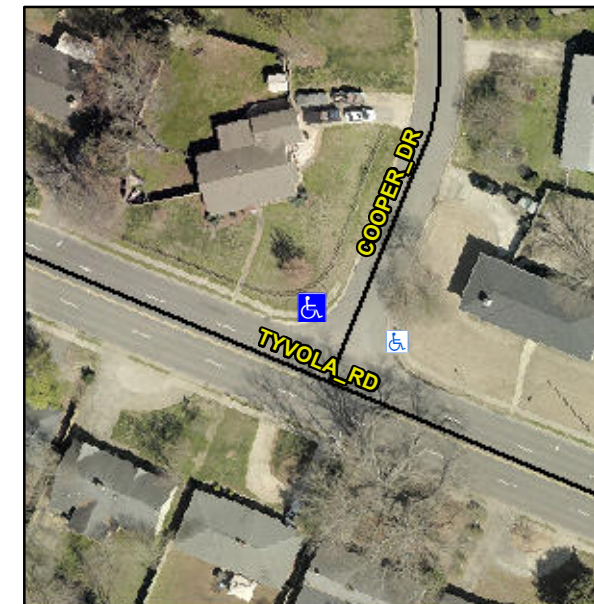
Not Found, R304.2.2, R304.5.3

Compliance	Description	Data	Compliance	Description	Data
N/A	Ramp Length (in)	22.0	No	Ramp Slope (%)	9.4
Yes	Ramp Width (in)	60.0	No	Ramp XSlope (%)	2.8
N/A	Flare Type LT	N/A	N/A	Flare Type RT	N/A
N/A	Flare Slope LT (%)	N/A	N/A	Flare Slope RT (%)	N/A
N/A	Flare Traversable LT?	N/A	N/A	Flare Traversable RT?	N/A
N/A	Landing Length (in)	N/A	N/A	DWS Provided?	N/A
N/A	Landing Width (in)	N/A	N/A	DWS Contrast?	N/A
N/A	Landing Slope (%)	N/A	N/A	DWS Length (in)	N/A
N/A	Landing X Slope (%)	N/A	N/A	DWS Full Width?	N/A
N/A	Landing Curb? (Y/N)	N/A	N/A	DWS Offset (in)	N/A
N/A	Shared Landing?	N/A			
N/A	Gutter Ponding?	N/A	N/A	Gutter Slope (%)	N/A
N/A	Gutter Lip Ht (in)	N/A	N/A	Gutter X Slope (%)	N/A
N/A	Painted X Walk1?	No	N/A	Painted X Walk2?	No
	X Walk 1 Direction	To SW		X Walk 2 Direction	To SE
N/A	X Walk 1 Width (in)	N/A	N/A	X Walk 2 Width (in)	N/A
	X Walk 1 Slope (%)	3.8		X Walk 2 Slope (%)	4.5
	X Walk 1 X Slope (%)	0.1		X Walk 2 X Slope (%)	2.7

N/A	Ramp inside XWalk1?	N/A	N/A	Ramp inside XWalk2?	N/A
	Road Slope (%)	1.5	N/A	Clear Space?	N/A
	Road X Slope (%)	2.5	N/A	Clear Space to XWalk (in)	N/A
N/A	Any Obstructions?	N/A	N/A	Storm Grate/Utility Hazard?	N/A
	Obstruction Type			Storm Grate/Utility Type	
		N/A			N/A
		Yes		Surface Condition? (G/P)	Good

Possible Solutions:

Remove & Replace Curb Ramp With Two New Directional Ramps or Equivalent.

Total Cost: \$ 3200.00
