Access Compliance Report

Public Rights-of-Way

(Curb Ramps)

Intersection ID: 49696	Main Street: MADISON HILL CT	Cross Street: THISTLE FIELD LN	Location: SE
ADA ID: 308A2193CB6E	Ramp Type: Perp	Initial Pass/Fail: Pass	Overall Compliance: No
Severity Score: 0			
Codes/Mitigation Info/Possible Solution		Field Measurements/Component Compliance

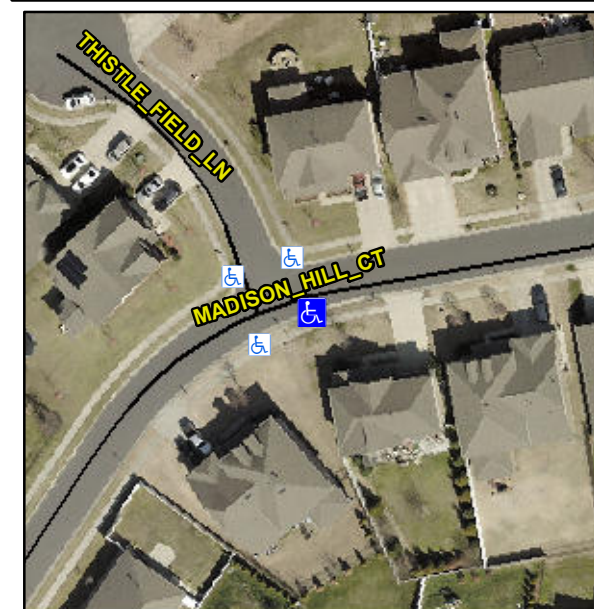
Compliance	Description	Data	Compliance	Description	Data
N/A	Ramp Length (in)	47.5	Yes	Ramp Slope (%)	7.0
Yes	Ramp Width (in)	48.0	Yes	Ramp XSlope (%)	0.8
N/A	Flare Type LT	Sloped	N/A	Flare Type RT	N/A
N/A	Flare Slope LT (%)	3.6	Yes	Flare Slope RT (%)	3.0
N/A	Flare Traversable LT?	Yes	N/A	Flare Traversable RT?	Yes
Yes	Landing Length (in)	48.0	Yes	DWS Provided?	Yes
Yes	Landing Width (in)	48.0	Yes	DWS Contrast?	Yes
No	Landing Slope (%)	2.1	Yes	DWS Length (in)	24.0
Yes	Landing X Slope (%)	1.4	Yes	DWS Full Width?	Yes
N/A	Landing Curb? (Y/N)	No	No	DWS Offset (in)	3.0
N/A	Shared Landing?	No			
Yes	Gutter Ponding?	No	Yes	Gutter Slope (%)	0.0
Yes	Gutter Lip Ht (in)	0.0	Yes	Gutter X Slope (%)	0.9
N/A	Painted X Walk1?	No	N/A	Painted X Walk2?	N/A
	X Walk 1 Direction	To NW		X Walk 2 Direction	N/A
N/A	X Walk 1 Width (in)	N/A	N/A	X Walk 2 Width (in)	N/A
	X Walk 1 Slope (%)	2.3		X Walk 2 Slope (%)	N/A
	X Walk 1 X Slope (%)	0.6		X Walk 2 X Slope (%)	N/A

N/A	Ramp inside XWalk1?	N/A	N/A	Ramp inside XWalk2?	N/A
	Road Slope (%)	N/A	N/A	Clear Space?	Yes
	Road X Slope (%)	N/A	N/A	Clear Space to XWalk (in)	N/A
Yes	Any Obstructions?	No	Yes	Storm Grate/Utility Hazard?	No
	Obstruction Type			Storm Grate/Utility Type	
		N/A			N/A
			Yes	Surface Condition? (G/P)	Good

Possible Solutions:

Remove & Replace Entire Ramp.

Not Found, R304.2.2-Perp, R304.3.2-Para, R305.2
