Access Compliance Report

Public Rights-of-Way

(Curb Ramps)

Intersection ID: 10035268	Main Street: QUEENS_RD	Cross Street: N/A	Location: NE
ADA ID: 309AEB788993	Ramp Type: Perp	Initial Pass/Fail: Fail	Overall Compliance: No
Codes/Mitigation Info/Possible Solution		Field Measurements/Component Compliance	
Severity Score: 33.75

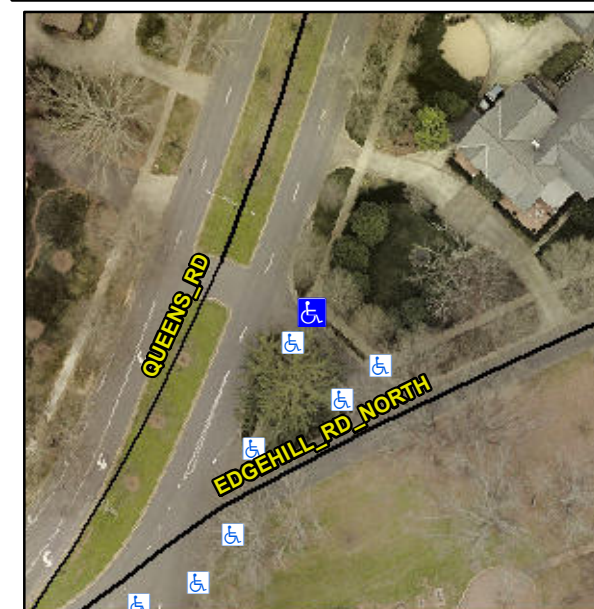
Compliance	Description	Data	Compliance	Description	Data
N/A	Ramp Length (in)	43.0	No	Ramp Slope (%)	13.4
No	Ramp Width (in)	42.0	Yes	Ramp XSlope (%)	0.3
N/A	Flare Type LT	N/A	N/A	Flare Type RT	N/A
N/A	Flare Slope LT (%)	N/A	N/A	Flare Slope RT (%)	N/A
N/A	Flare Traversable LT?	N/A	N/A	Flare Traversable RT?	N/A
N/A	Landing Length (in)	N/A	N/A	DWS Provided?	N/A
N/A	Landing Width (in)	N/A	N/A	DWS Contrast?	N/A
N/A	Landing Slope (%)	N/A	N/A	DWS Length (in)	N/A
N/A	Landing X Slope (%)	N/A	N/A	DWS Full Width?	N/A
N/A	Landing Curb? (Y/N)	N/A	N/A	DWS Offset (in)	N/A
N/A	Shared Landing?	N/A			
N/A	Gutter Ponding?	N/A	N/A	Gutter Slope (%)	N/A
N/A	Gutter Lip Ht (in)	N/A	N/A	Gutter X Slope (%)	N/A
N/A	Painted X Walk1?	No	N/A	Painted X Walk2?	N/A
	X Walk 1 Direction	To SW		X Walk 2 Direction	N/A
N/A	X Walk 1 Width (in)	N/A	N/A	X Walk 2 Width (in)	N/A
	X Walk 1 Slope (%)	3.1		X Walk 2 Slope (%)	N/A
	X Walk 1 X Slope (%)	2.2		X Walk 2 X Slope (%)	N/A

N/A	Ramp inside XWalk1?	N/A	N/A	Ramp inside XWalk2?	N/A
	Road Slope (%)	N/A	N/A	Clear Space?	N/A
	Road X Slope (%)	N/A	N/A	Clear Space to XWalk (in)	N/A
N/A	Any Obstructions?	N/A	N/A	Storm Grate/Utility Hazard?	N/A
	Obstruction Type			Storm Grate/Utility Type	
		N/A			N/A
		Yes		Surface Condition? (G/P)	Good

Possible Solutions:

Remove & Replace Entire Ramp.

PROW/ADA:

R304.5.1, R304.2.2

Total Cost:

\$ 1850.00
