Access Compliance Report

Public Rights-of-Way

(Curb Ramps)

Intersection ID: 31171	Main Street: POINTER_RD	Cross Street: BROWNE_RD	Location: NE
ADA ID: 30A3E91C1B8F	Ramp Type: Perp	Initial Pass/Fail: Fail	Overall Compliance: No
			Severity Score: 13.75

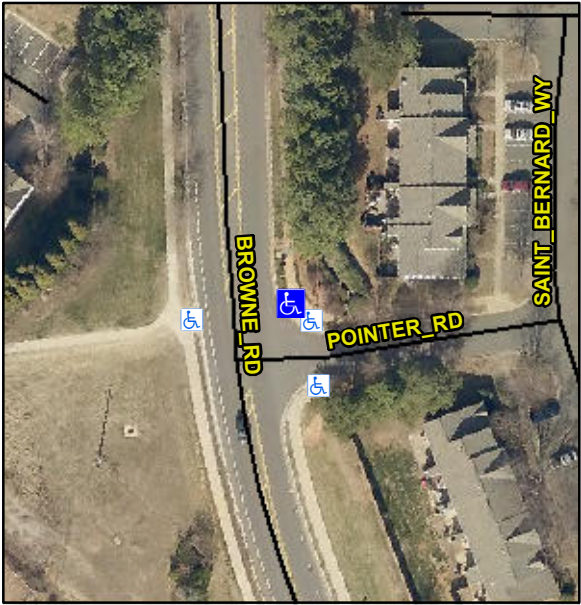
Possible Solutions:		Compliance	Description	Data
	Remove & Replace Entire Ramp.		N/A	Ramp Length (in)	57.0
			Yes	Ramp Width (in)	48.0
			N/A	Flare Type LT	N/A
			N/A	Flare Slope LT (%)	N/A
			N/A	Flare Traversable LT?	N/A
			N/A	Landing Length (in)	N/A
			N/A	Landing Width (in)	N/A
			N/A	Landing Slope (%)	N/A
			N/A	Landing X Slope (%)	N/A
<p>Surveyor Notes:</p> <p>N/A</p> <p>PROW/ADA:</p> <p>R304.2.2, R304.5.3</p>			N/A	Flare Type RT	N/A
			N/A	Flare Slope RT (%)	N/A
			N/A	Flare Traversable RT?	N/A
			N/A	DWS Provided?	N/A
			N/A	DWS Contrast?	N/A
			N/A	DWS Length (in)	N/A
			N/A	DWS Full Width?	N/A
			N/A	DWS Offset (in)	N/A
			N/A	Shared Landing?	N/A
			N/A	Gutter Ponding?	N/A
			N/A	Gutter Lip Ht (in)	N/A
			N/A	Painted X Walk1?	No
				X Walk 1 Direction	To W
			N/A	X Walk 1 Width (in)	N/A
				X Walk 1 Slope (%)	5.1
				X Walk 1 X Slope (%)	1.4

N/A	Ramp inside XWalk1?	N/A
			N/A	Road Slope (%)	N/A
			N/A	Road X Slope (%)	N/A
			N/A	Any Obstructions?	N/A
				Obstruction Type	
Total Cost:		\$ 1850.00			
			N/A		N/A
			Yes	Surface Condition? (G/P)	Good
