# Access Compliance Report

## Public Rights-of-Way

### (Curb Ramps)

Intersection ID: 11526	Main Street: W_8TH_ST	Cross Street: N_GRAHAM_ST	Location: W
ADA ID: 30A5BB7DFCE2	Ramp Type: PerpDiag	Initial Pass/Fail: Pass	Overall Compliance: No
Severity Score: 17.75			
Codes/Mitigation Info/Possible Solution		Field Measurements/Component Compliance

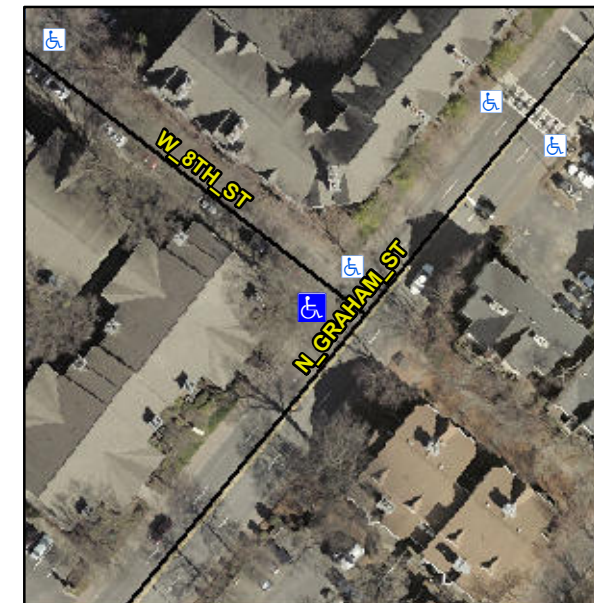
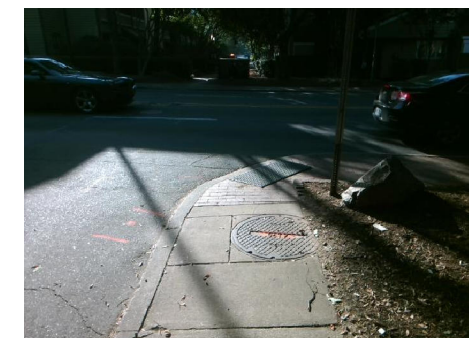
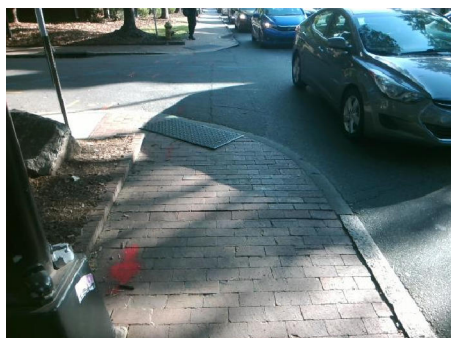
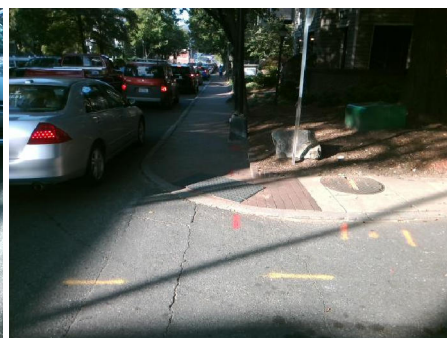
Compliance	Description	Data	Compliance	Description	Data
N/A	Ramp Length (in)	36.0	Yes	Ramp Slope (%)	6.5
Yes	Ramp Width (in)	48.0	No	Ramp XSlope (%)	2.5
N/A	Flare Type LT	Sloped	N/A	Flare Type RT	N/A
N/A	Flare Slope LT (%)	2.0	Yes	Flare Slope RT (%)	5.2
N/A	Flare Traversable LT?	Yes	N/A	Flare Traversable RT?	Yes
No	Landing Length (in)	N/A	Yes	DWS Provided?	Yes
No	Landing Width (in)	N/A	Yes	DWS Contrast?	Yes
No	Landing Slope (%)	N/A	Yes	DWS Length (in)	24.0
No	Landing X Slope (%)	N/A	Yes	DWS Full Width?	Yes
N/A	Landing Curb? (Y/N)	No	No	DWS Offset (in)	3.0
N/A	Shared Landing?	No			
Yes	Gutter Ponding?	No	Yes	Gutter Slope (%)	2.0
No	Gutter Lip Ht (in)	0.5	No	Gutter X Slope (%)	8.4
N/A	Painted X Walk1?	No	N/A	Painted X Walk2?	No
	X Walk 1 Direction	To SE		X Walk 2 Direction	To NE
N/A	X Walk 1 Width (in)	N/A	N/A	X Walk 2 Width (in)	N/A
	X Walk 1 Slope (%)	0.4		X Walk 2 Slope (%)	5.3
	X Walk 1 X Slope (%)	4.0		X Walk 2 X Slope (%)	0.2

N/A	Ramp inside XWalk1?	N/A	N/A	Ramp inside XWalk2?	N/A
	Road Slope (%)	4.3	N/A	Clear Space?	No
	Road X Slope (%)	4.8	N/A	Clear Space to XWalk (in)	N/A
Yes	Any Obstructions?	No	Yes	Storm Grate/Utility Hazard?	No
	Obstruction Type			Storm Grate/Utility Type	
		N/A			N/A
			Yes	Surface Condition? (G/P)	Good

**Remove & Replace Curb Ramp With Two New Directional Ramps or Equivalent. Remove & Replace Gutter.**

Total Cost: \$ 3950.00
