# Access Compliance Report

## Public Rights-of-Way

### (Curb Ramps)

Intersection ID: 10593	Main Street: BEATTIES_FORD_RD	Cross Street: ROZZELLES_FERRY_RD	Location: SW
ADA ID: 30AD59F6CAB4	Ramp Type: BlendTrans1	Initial Pass/Fail: Fail	Overall Compliance: No
Codes/Mitigation Info/Possible Solution		Field Measurements/Component Compliance	
Severity Score: 8.75

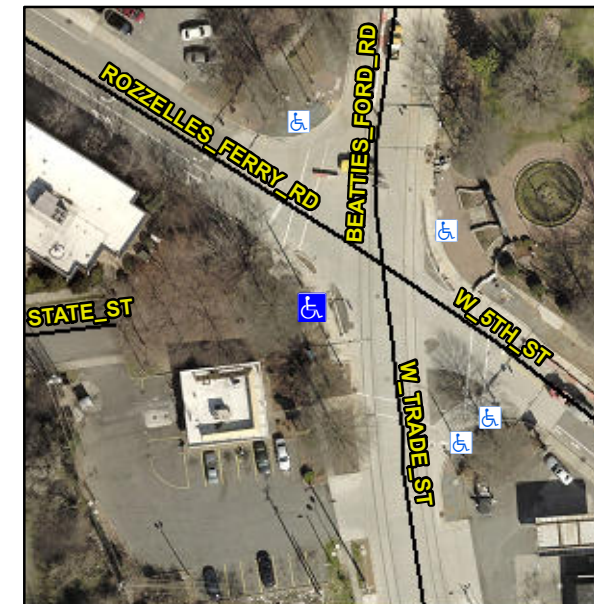
**Not Found, R304.5.1**

Compliance	Description	Data	Compliance	Description	Data
N/A	Ramp Length (in)	68.0	Yes	BlendTrans Slope (%)	2.7
No	Ramp Width (in)	39.5	Yes	BlendTrans XSlope (%)	1.2
N/A	Flare Type LT	N/A	N/A	Flare Type RT	N/A
N/A	Flare Slope LT (%)	N/A	N/A	Flare Slope RT (%)	N/A
N/A	Flare Traversable LT?	N/A	N/A	Flare Traversable RT?	N/A
N/A	Landing Length (in)	N/A	N/A	DWS Provided?	N/A
N/A	Landing Width (in)	N/A	N/A	DWS Contrast?	N/A
N/A	Landing Slope (%)	N/A	N/A	DWS Length (in)	N/A
N/A	Landing X Slope (%)	N/A	N/A	DWS Full Width?	N/A
N/A	Landing Curb? (Y/N)	N/A	N/A	DWS Offset (in)	N/A
N/A	Shared Landing?	N/A			
N/A	Gutter Ponding?	N/A	N/A	Gutter Slope (%)	N/A
N/A	Gutter Lip Ht (in)	0.5	N/A	Gutter X Slope (%)	N/A
N/A	Painted X Walk1?	Yes	N/A	Painted X Walk2?	Yes
	X Walk 1 Direction	To SE		X Walk 2 Direction	To N
	X Walk 1 Width (in)	115.0		X Walk 2 Width (in)	105.0
	X Walk 1 Slope (%)	2.2		X Walk 2 Slope (%)	2.9
	X Walk 1 X Slope (%)	1.6		X Walk 2 X Slope (%)	0.9

N/A	Ramp inside XWalk1?	Yes	N/A	Ramp inside XWalk2?	Yes
	Road Slope (%)	3.1		Clear Space?	N/A
	Road X Slope (%)	1.0	N/A	Clear Space to XWalk (in)	N/A
N/A	Any Obstructions?	N/A	N/A	Storm Grate/Utility Hazard?	N/A
	Obstruction Type			Storm Grate/Utility Type	
		N/A			N/A
			Yes	Surface Condition? (G/P)	Good
			No	Curb Slope (%)	7.0

**Remove & Replace Curb Ramp With Two New Directional Ramps or Equivalent.**
