# Access Compliance Report

## Public Rights-of-Way

### (Curb Ramps)

Intersection ID: 42580	Main Street: GERALDINE POWE DR	Cross Street: RISING OAK DR	Location: NE
ADA ID: 30AE20F6790F	Ramp Type: PerpDiag	Initial Pass/Fail: Fail	Overall Compliance: No
Severity Score: 36.25			
Codes/Mitigation Info/Possible Solution		Field Measurements/Component Compliance

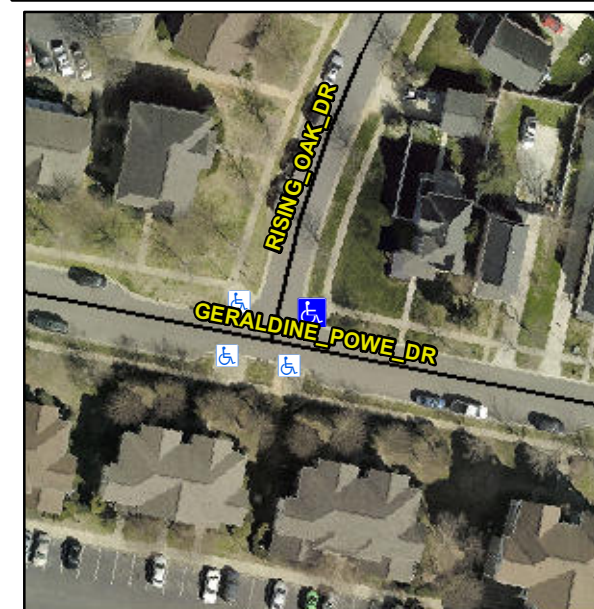
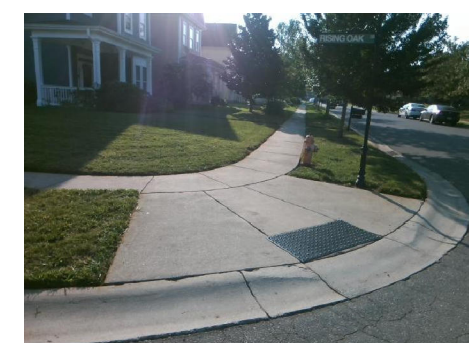
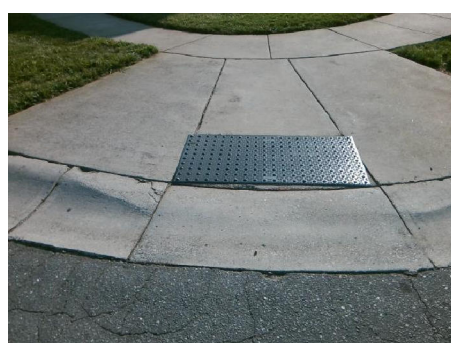
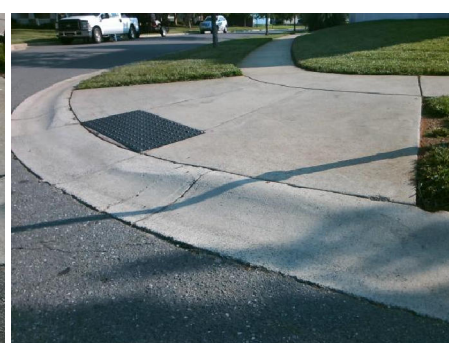
**Not Found, R304.5.1, R304.5.3**

Compliance	Description	Data	Compliance	Description	Data
N/A	Ramp Length (in)	95.0	Yes	Ramp Slope (%)	7.1
No	Ramp Width (in)	28.0	No	Ramp XSlope (%)	3.3
N/A	Flare Type LT	N/A	N/A	Flare Type RT	N/A
N/A	Flare Slope LT (%)	N/A	N/A	Flare Slope RT (%)	N/A
N/A	Flare Traversable LT?	N/A	N/A	Flare Traversable RT?	N/A
N/A	Landing Length (in)	N/A	N/A	DWS Provided?	N/A
N/A	Landing Width (in)	N/A	N/A	DWS Contrast?	N/A
N/A	Landing Slope (%)	N/A	N/A	DWS Length (in)	N/A
N/A	Landing X Slope (%)	N/A	N/A	DWS Full Width?	N/A
N/A	Landing Curb? (Y/N)	N/A	N/A	DWS Offset (in)	N/A
N/A	Shared Landing?	N/A			
N/A	Gutter Ponding?	N/A	N/A	Gutter Slope (%)	N/A
N/A	Gutter Lip Ht (in)	N/A	N/A	Gutter X Slope (%)	N/A
N/A	Painted X Walk1?	No	N/A	Painted X Walk2?	No
	X Walk 1 Direction	To W		X Walk 2 Direction	To S
N/A	X Walk 1 Width (in)	N/A	N/A	X Walk 2 Width (in)	N/A
	X Walk 1 Slope (%)	2.0		X Walk 2 Slope (%)	6.0
	X Walk 1 X Slope (%)	3.6		X Walk 2 X Slope (%)	2.1

N/A	Ramp inside XWalk1?	N/A	N/A	Ramp inside XWalk2?	N/A
	Road Slope (%)	2.0	N/A	Clear Space?	N/A
	Road X Slope (%)	1.0	N/A	Clear Space to XWalk (in)	N/A
N/A	Any Obstructions?	N/A	N/A	Storm Grate/Utility Hazard?	N/A
	Obstruction Type			Storm Grate/Utility Type	
		N/A			N/A
		Yes		Surface Condition? (G/P)	Good

**Remove & Replace Curb Ramp With Two New Directional Ramps or Equivalent.**

Total Cost: \$ 3200.00
