# Access Compliance Report

## Public Rights-of-Way

### (Curb Ramps)

Intersection ID: 10154	Main Street: SLOAN_DR	Cross Street: TUCKASEEGEE_RD	Location: W
ADA ID: 30B2AC1E1773	Ramp Type: Perp	Initial Pass/Fail: Fail	Overall Compliance: No
			Severity Score: 21.25

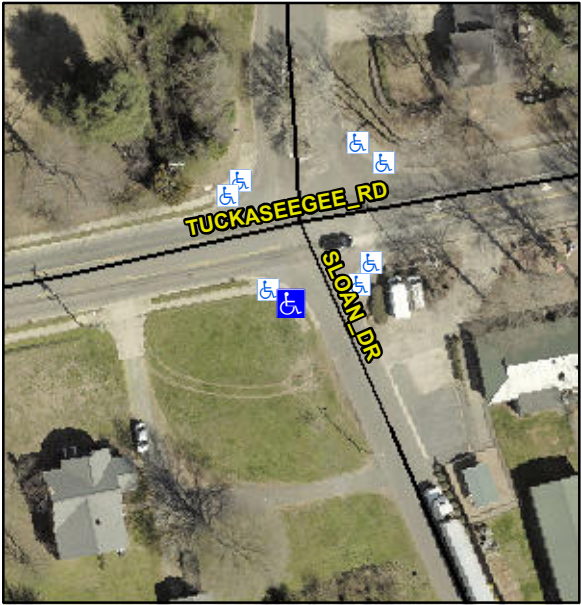
Possible Solutions:		<b>Compliance</b>	<b>Description</b>	<b>Data</b>
	Remove & Replace Entire Ramp.		N/A	Ramp Length (in)	82.0
			No	Ramp Width (in)	46.0
			N/A	Flare Type LT	N/A
			N/A	Flare Slope LT (%)	N/A
			N/A	Flare Traversable LT?	N/A
			N/A	Landing Length (in)	N/A
			N/A	Landing Width (in)	N/A
			N/A	Landing Slope (%)	N/A
			N/A	Landing X Slope (%)	N/A
<p>Surveyor Notes:</p> <p>N/A</p> <p>PROW/ADA:</p> <p>R304.5.1, R304.2.2</p>			N/A	Flare Type RT	N/A
			N/A	Flare Slope RT (%)	N/A
			N/A	Flare Traversable RT?	N/A
			N/A	DWS Provided?	N/A
			N/A	DWS Contrast?	N/A
			N/A	DWS Length (in)	N/A
			N/A	DWS Full Width?	N/A
			N/A	DWS Offset (in)	N/A
			N/A	Gutter Ponding?	N/A
			N/A	Gutter Lip Ht (in)	N/A
<p>Total Cost:</p> <p>\$ 1850.00</p>			N/A	Painted X Walk1?	No
				X Walk 1 Direction	To E
			N/A	X Walk 1 Width (in)	N/A

X Walk 1 Slope (%)	1.6
				X Walk 1 X Slope (%)	1.6
			N/A	Ramp inside XWalk1?	N/A
				Road Slope (%)	N/A
				Road X Slope (%)	N/A
			N/A	Any Obstructions?	N/A
				Obstruction Type	
			N/A		N/A
			Yes	Surface Condition? (G/P)	Good
