Access Compliance Report

Public Rights-of-Way

(Curb Ramps)

Intersection ID: 44190	Main Street: ROZZELLES_LANDING_DR	Cross Street: CODDINGTON_RIDGE_DR	Location: SE
ADA ID: 30BD2743508D	Ramp Type: Perp	Initial Pass/Fail: Fail	Overall Compliance: No
Codes/Mitigation Info/Possible Solution		Field Measurements/Component Compliance	
Severity Score: 8.75

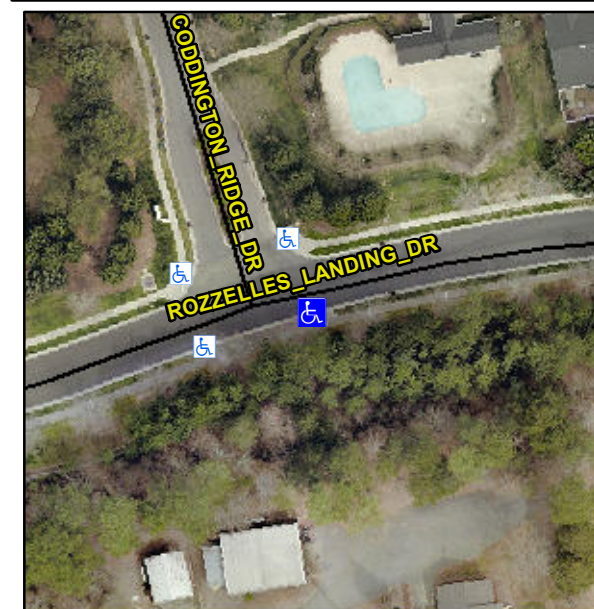
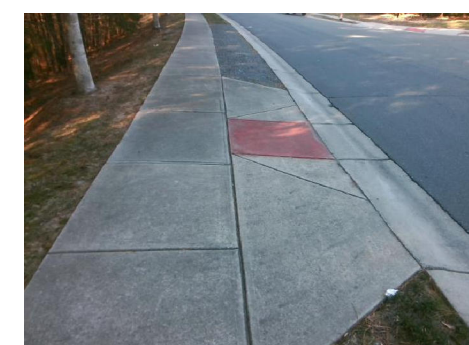
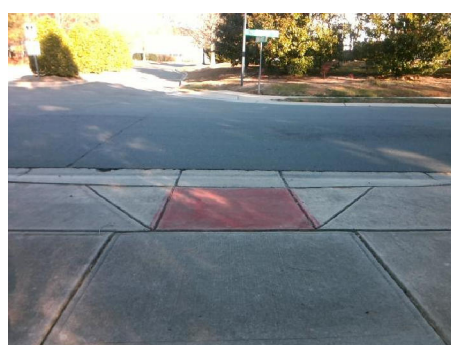
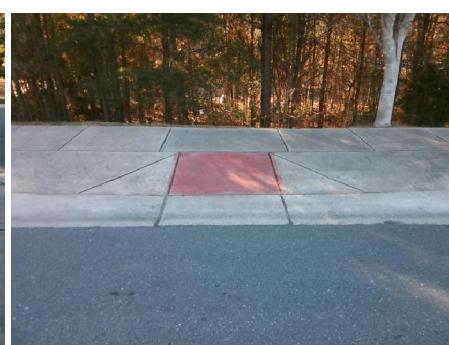
R304.5.1

Compliance	Description	Data	Compliance	Description	Data
N/A	Ramp Length (in)	47.0	Yes	Ramp Slope (%)	6.9
No	Ramp Width (in)	47.0	Yes	Ramp XSlope (%)	1.4
N/A	Flare Type LT	N/A	N/A	Flare Type RT	N/A
N/A	Flare Slope LT (%)	N/A	N/A	Flare Slope RT (%)	N/A
N/A	Flare Traversable LT?	N/A	N/A	Flare Traversable RT?	N/A
N/A	Landing Length (in)	N/A	N/A	DWS Provided?	N/A
N/A	Landing Width (in)	N/A	N/A	DWS Contrast?	N/A
N/A	Landing Slope (%)	N/A	N/A	DWS Length (in)	N/A
N/A	Landing X Slope (%)	N/A	N/A	DWS Full Width?	N/A
N/A	Landing Curb? (Y/N)	N/A	N/A	DWS Offset (in)	N/A
N/A	Shared Landing?	N/A			
N/A	Gutter Ponding?	N/A	N/A	Gutter Slope (%)	N/A
N/A	Gutter Lip Ht (in)	N/A	N/A	Gutter X Slope (%)	N/A
N/A	Painted X Walk1?	No	N/A	Painted X Walk2?	N/A
	X Walk 1 Direction	To N		X Walk 2 Direction	N/A
N/A	X Walk 1 Width (in)	N/A	N/A	X Walk 2 Width (in)	N/A
	X Walk 1 Slope (%)	4.8		X Walk 2 Slope (%)	N/A
	X Walk 1 X Slope (%)	0.8		X Walk 2 X Slope (%)	N/A

N/A	Ramp inside XWalk1?	N/A	N/A	Ramp inside XWalk2?	N/A
	Road Slope (%)	N/A	N/A	Clear Space?	N/A
	Road X Slope (%)	N/A	N/A	Clear Space to XWalk (in)	N/A
N/A	Any Obstructions?	N/A	N/A	Storm Grate/Utility Hazard?	N/A
	Obstruction Type			Storm Grate/Utility Type	
		N/A			N/A
		Yes		Surface Condition? (G/P)	Good

Remove & Replace Entire Ramp.

Total Cost: \$ 1850.00
