Access Compliance Report

Public Rights-of-Way

(Curb Ramps)

Intersection ID: 15070	Main Street: IDEAL_WY	Cross Street: REMOUNT_RD	Location:	N
ADA ID: 30BE0A7F9052	Ramp Type: Perp	Initial Pass/Fail: Fail	Overall Compliance: No	Severity Score: 12.5

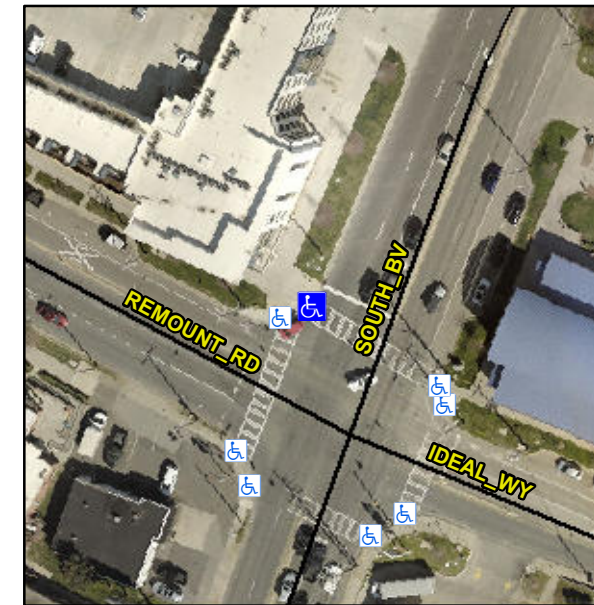
Not Found, R304.2.2

Compliance	Description	Data	Compliance	Description	Data
N/A	Ramp Length (in)	71.0	No	Ramp Slope (%)	9.2
Yes	Ramp Width (in)	49.0	Yes	Ramp XSlope (%)	0.1
N/A	Flare Type LT	N/A	N/A	Flare Type RT	N/A
N/A	Flare Slope LT (%)	N/A	N/A	Flare Slope RT (%)	N/A
N/A	Flare Traversable LT?	N/A	N/A	Flare Traversable RT?	N/A
N/A	Landing Length (in)	N/A	N/A	DWS Provided?	N/A
N/A	Landing Width (in)	N/A	N/A	DWS Contrast?	N/A
N/A	Landing Slope (%)	N/A	N/A	DWS Length (in)	N/A
N/A	Landing X Slope (%)	N/A	N/A	DWS Full Width?	N/A
N/A	Landing Curb? (Y/N)	N/A	N/A	DWS Offset (in)	N/A
N/A	Shared Landing?	N/A			
N/A	Gutter Ponding?	N/A	N/A	Gutter Slope (%)	N/A
N/A	Gutter Lip Ht (in)	N/A	N/A	Gutter X Slope (%)	N/A
N/A	Painted X Walk1?	Yes	N/A	Painted X Walk2?	N/A
	X Walk 1 Direction	To SE		X Walk 2 Direction	N/A
N/A	X Walk 1 Width (in)	122.0	N/A	X Walk 2 Width (in)	N/A
	X Walk 1 Slope (%)	0.0		X Walk 2 Slope (%)	N/A
	X Walk 1 X Slope (%)	0.4		X Walk 2 X Slope (%)	N/A

N/A	Ramp inside XWalk1?	Yes	N/A	Ramp inside XWalk2?	N/A
	Road Slope (%)	N/A	N/A	Clear Space?	N/A
	Road X Slope (%)	N/A	N/A	Clear Space to XWalk (in)	N/A
N/A	Any Obstructions?	N/A	N/A	Storm Grate/Utility Hazard?	N/A
	Obstruction Type			Storm Grate/Utility Type	
		N/A			N/A
			Yes	Surface Condition? (G/P)	Good

Remove & Replace Entire Ramp.

Total Cost: \$ 1850.00
