Access Compliance Report Public Rights-of-Way (Curb Ramps)

Intersection ID: 11287 Main Street: CATAWBA_AV Cross Street: UMSTEAD_ST Location: SW

ADA ID: 30C6EC6CB9BE Ramp Type: Perp Initial Pass/Fail: Fail Overall Compliance: No Severity Score: 13.75

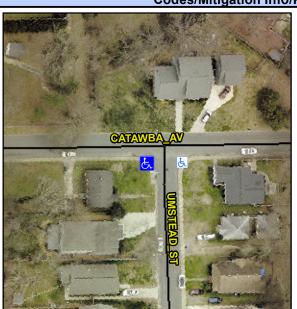
Compl	iance Description	Data			Description	Data
N/A	Ramp Length (in)	56.0	No	Ramp	Slope (%)	10.3
Yes	Ramp Width (in)	48.0	No	Ramp	XSlope (%)	2.4
N/A	Flare Type LT	N/A	N/A	Flare	Type RT	N/A
N/A	Flare Slope LT (%)	N/A	N/A	Flare	Slope RT (%)	N/A
N/A	Flare Traversable LT?	N/A	N/A	Flare	Traversable RT?	N/A
N/A	Landing Length (in)	N/A	N/A	DWS	Provided?	N/A
N/A	Landing Width (in)	N/A	N/A	DWS	Contrast?	N/A
N/A	Landing Slope (%)	N/A	N/A	DWS	Length (in)	N/A
N/A	Landing X Slope (%)	N/A	N/A	DWS	Full Width?	N/A
N/A	Landing Curb? (Y/N)	N/A	N/A	DWS	Offset (in)	N/A
N/A	Shared Landing?	N/A				
N/A	Gutter Ponding?	N/A	N/A	Gutte	er Slope (%)	N/A
N/A	Gutter Lip Ht (in)	N/A	N/A	Gutte	er X Slope (%)	N/A
N/A	Painted X Walk1?	No	N/A	Paint	ed X Walk2?	N/A
	X Walk 1 Direction	To SE		X Wa	lk 2 Direction	N/A
N/A	X Walk 1 Width (in)	N/A	N/A	X Wa	lk 2 Width (in)	N/A
	X Walk 1 Slope (%)	0.2		X Wa	lk 2 Slope (%)	N/A
	X Walk 1 X Slope (%)	1.7		X Wa	lk 2 X Slope (%)	N/A

N/A	Ramp inside XWalk1?	N/A	N/A	Ram	o inside XWalk2?	N/A
	Road Slope (%)	N/A	N/A	Clear	Space?	N/A
	Road X Slope (%)	N/A	N/A	Clear	Space to XWalk (in)	N/A
N/A	Any Obstructions?	N/A	N/A	Storn	n Grate/Utility Hazard?	N/A
	Obstruction Type			Storn	n Grate/Utility Type	
		N/A				N/A
			Yes	Surfa	ice Condition? (G/P)	Good

Possible Solution	
Possible Solutions:	Co
Remove & Replace Entire Ramp.	N/A
·	Yes
	N/A
	N/A
	N/A
	N/A
Surveyor Notes:	N/A
N/A	N/A
	N/A
	N/A
	N/A
PROW/ADA:	N/A
R304.2.2, R304.5.3	N/A
,	N/A
	N/A

14//
PROW/ADA:		N/A
R304.2.2, R304.5.3		N/A
,		N/A
		N/A
		N/A
		N/A
Total Cost:	\$ 1850.00
