Access Compliance Report

Public Rights-of-Way

(Curb Ramps)

Intersection ID: N/A	Main Street: S_MCDOWELL_ST	Cross Street: E_STONEWALL_ST	Location: SW
ADA ID: 30CA9CE7798E	Ramp Type: Perp	Initial Pass/Fail: Pass	Overall Compliance: No
		Severity Score: 0	
Codes/Mitigation Info/Possible Solution		Field Measurements/Component Compliance

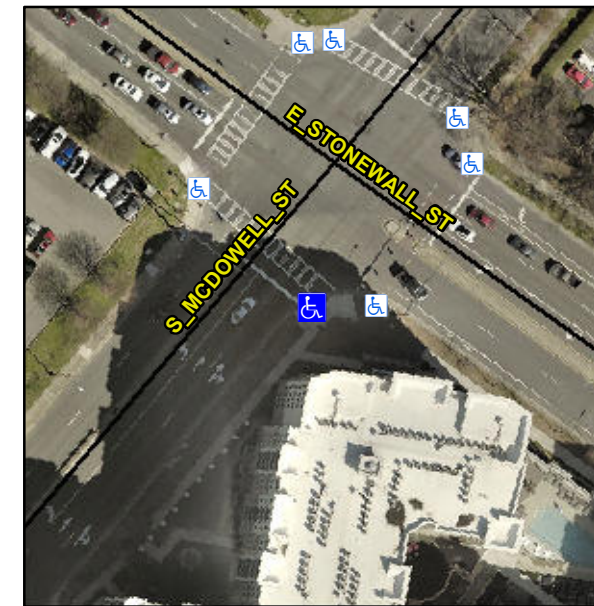
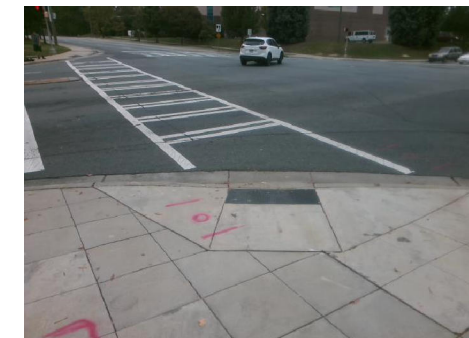
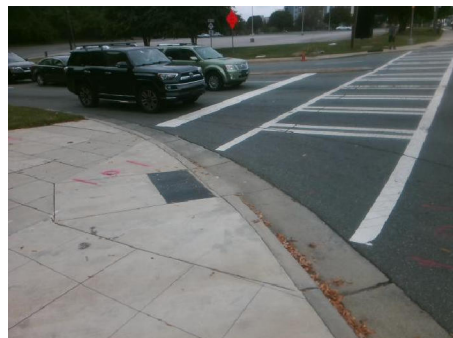
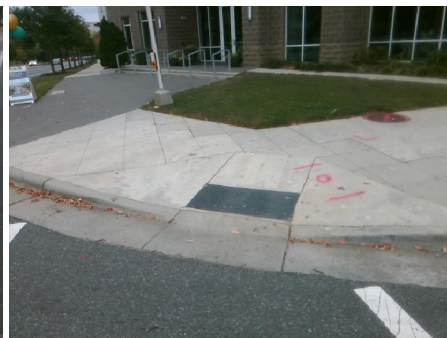
Compliance	Description	Data	Compliance	Description	Data
N/A	Ramp Length (in)	71.5	Yes	Ramp Slope (%)	7.5
Yes	Ramp Width (in)	48.0	Yes	Ramp XSlope (%)	0.8
N/A	Flare Type LT	Sloped	N/A	Flare Type RT	N/A
N/A	Flare Slope LT (%)	5.4	Yes	Flare Slope RT (%)	7.6
N/A	Flare Traversable LT?	Yes	N/A	Flare Traversable RT?	Yes
Yes	Landing Length (in)	48.0	Yes	DWS Provided?	Yes
Yes	Landing Width (in)	48.0	Yes	DWS Contrast?	Yes
No	Landing Slope (%)	3.2	Yes	DWS Length (in)	24.0
Yes	Landing X Slope (%)	0.8	Yes	DWS Full Width?	Yes
N/A	Landing Curb? (Y/N)	No	Yes	DWS Offset (in)	2.0
N/A	Shared Landing?	No			
Yes	Gutter Ponding?	No	Yes	Gutter Slope (%)	1.2
Yes	Gutter Lip Ht (in)	0.0	Yes	Gutter X Slope (%)	0.1
N/A	Painted X Walk1?	Yes	N/A	Painted X Walk2?	N/A
	X Walk 1 Direction	To NW		X Walk 2 Direction	N/A
N/A	X Walk 1 Width (in)	110.0	N/A	X Walk 2 Width (in)	N/A
	X Walk 1 Slope (%)	4.2		X Walk 2 Slope (%)	N/A
	X Walk 1 X Slope (%)	2.8		X Walk 2 X Slope (%)	N/A

Yes	Ramp inside XWalk1?	Yes	N/A	Ramp inside XWalk2?	N/A
	Road Slope (%)	N/A	N/A	Clear Space?	Yes
	Road X Slope (%)	N/A	N/A	Clear Space to XWalk (in)	N/A
Yes	Any Obstructions?	No	Yes	Storm Grate/Utility Hazard?	No
	Obstruction Type			Storm Grate/Utility Type	
		N/A			N/A
			Yes	Surface Condition? (G/P)	Good

Possible Solutions:

Remove & Replace Landing.

R304.2.2-Perp, R304.3.2-Para
