Access Compliance Report

Public Rights-of-Way

(Curb Ramps)

Intersection ID: 17651	Main Street: CHELSEA_DR	Cross Street: HILLSIDE_AV	Location: NE
ADA ID: 30CF0308E323	Ramp Type: Directional1	Initial Pass/Fail: Fail	Overall Compliance: No
Codes/Mitigation Info/Possible Solution		Field Measurements/Component Compliance	
Severity Score: 13.75

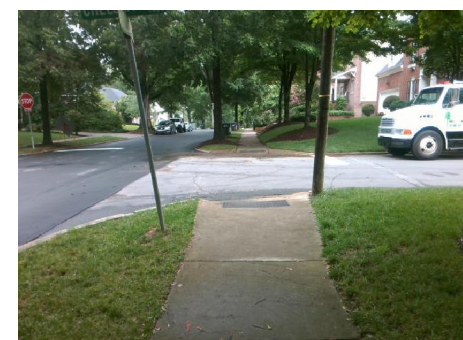
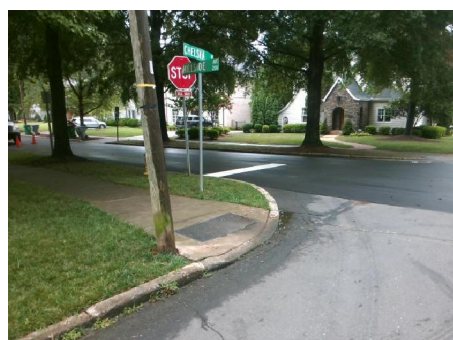
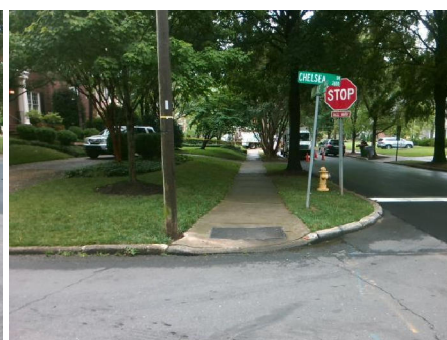
R304.2.2, R304.5.3

Compliance	Description	Data	Compliance	Description	Data
N/A	Ramp Length (in)	48.0	N/A	Grade Break?	N/A
Yes	Ramp Width (in)	48.0	N/A	Grade Break Slope (%)	0.0
No	Ramp Slope (%)	8.4	N/A	Grade Break XSlope (%)	0.0
No	Ramp XSlope (%)	2.6			
N/A	Flare Type LT	N/A	N/A	Flare Type RT	N/A
N/A	Flare Slope LT (%)	N/A	N/A	Flare Slope RT (%)	0.0
N/A	Flare Traversable LT?	N/A	N/A	Flare Traversable RT?	N/A
N/A	Landing Length (in)	0.0	N/A	DWS Provided?	N/A
N/A	Landing Width (in)	0.0	N/A	DWS Contrast?	N/A
N/A	Landing Slope (%)	0.0	N/A	DWS Length (in)	N/A
N/A	Landing X Slope (%)	0.0	N/A	DWS Full Width?	N/A
N/A	Landing Curb? (Y/N)	N/A	N/A	DWS Offset LT (in)	N/A
N/A	Shared Landing?	N/A	N/A	DWS Offset RT (in)	N/A
N/A	Gutter Ponding?	0.0	N/A	Gutter Slope (%)	N/A
N/A	Gutter Lip Ht (in)	0.0	N/A	Gutter X Slope (%)	N/A
N/A	Painted X Walk1?	No		Road Slope (%)	3.3
	X Walk 1 Direction	To W		Road X Slope (%)	0.4
	X Walk 1 Width (in)	N/A		Clear Space?	N/A

X Walk 1 Slope (%)	3.3	N/A	Clear Space to XWalk (in)	N/A
	X Walk 1 X Slope (%)	0.4	N/A	Storm Grate/Utility Hazard?	N/A
N/A	Ramp inside XWalk1?	N/A		Storm Grate/Utility Type	
N/A	Any Obstructions?	N/A			N/A
	Obstruction Type		Yes	Surface Condition? (G/P)	Good
			N/A	Curb Slope (%)	9.2

Possible Solutions:

Remove & Replace Entire Ramp.
