# Access Compliance Report

## Public Rights-of-Way

### (Curb Ramps)

Intersection ID: 11676	Main Street: HAWTHORNE_LN	Cross Street: PARKWOOD_AV	Location: SE
ADA ID: 30D3A22BB8F6	Ramp Type: Perp	Initial Pass/Fail: Fail	Overall Compliance: No
			Severity Score: 21.25

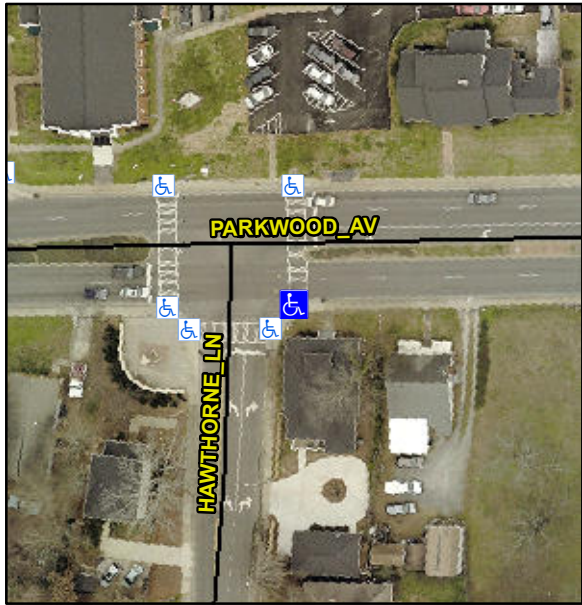
Possible Solutions:		Compliance	Description	Data	Compliance	Description	Data
	Remove & Replace Entire Ramp.		N/A	Ramp Length (in)	47.5	No	Ramp Slope (%)	8.7
			No	Ramp Width (in)	47.5	Yes	Ramp XSlope (%)	1.2
			N/A	Flare Type LT	N/A	N/A	Flare Type RT	N/A
			N/A	Flare Slope LT (%)	N/A	N/A	Flare Slope RT (%)	N/A
			N/A	Flare Traversable LT?	N/A	N/A	Flare Traversable RT?	N/A
			N/A	Landing Length (in)	N/A	N/A	DWS Provided?	N/A
			N/A	Landing Width (in)	N/A	N/A	DWS Contrast?	N/A
			N/A	Landing Slope (%)	N/A	N/A	DWS Length (in)	N/A
			N/A	Landing X Slope (%)	N/A	N/A	DWS Full Width?	N/A
Surveyor Notes:		N/A	N/A	Landing Curb? (Y/N)	N/A	N/A	DWS Offset (in)	N/A
PROW/ADA:		Not Found, R304.5.1, R304.2.2	N/A	Shared Landing?	N/A			
			N/A	Gutter Ponding?	N/A	N/A	Gutter Slope (%)	N/A
			N/A	Gutter Lip Ht (in)	N/A	N/A	Gutter X Slope (%)	N/A

N/A	Painted X Walk1?	Yes	N/A	Painted X Walk2?	N/A
				X Walk 1 Direction	To N		X Walk 2 Direction	N/A
			N/A	X Walk 1 Width (in)	108.0	N/A	X Walk 2 Width (in)	N/A
				X Walk 1 Slope (%)	2.8		X Walk 2 Slope (%)	N/A
				X Walk 1 X Slope (%)	3.9		X Walk 2 X Slope (%)	N/A
Street 1 Name		PARKWOOD AV	N/A	Ramp inside XWalk1?	Yes	N/A	Ramp inside XWalk2?	N/A
Stop Condition-Street 2		Signal		Road Slope (%)	N/A	N/A	Clear Space?	N/A
Street 2 Name		N/A		Road X Slope (%)	N/A	N/A	Clear Space to XWalk (in)	N/A
Stop Condition-Street 1		N/A	N/A	Any Obstructions?	N/A	N/A	Storm Grate/Utility Hazard?	N/A
				Obstruction Type			Storm Grate/Utility Type	
Total Cost:		\$ 1850.00			N/A			N/A
						Yes	Surface Condition? (G/P)	Good
