Access Compliance Report

Public Rights-of-Way

(Curb Ramps)

Intersection ID: 14038	Main Street: RIDGE_AV	Cross Street: WEST_BV	Location: SE
ADA ID: 30DA1574DE99	Ramp Type: PerpDiag	Initial Pass/Fail: Fail	Overall Compliance: No
		Severity Score: 10

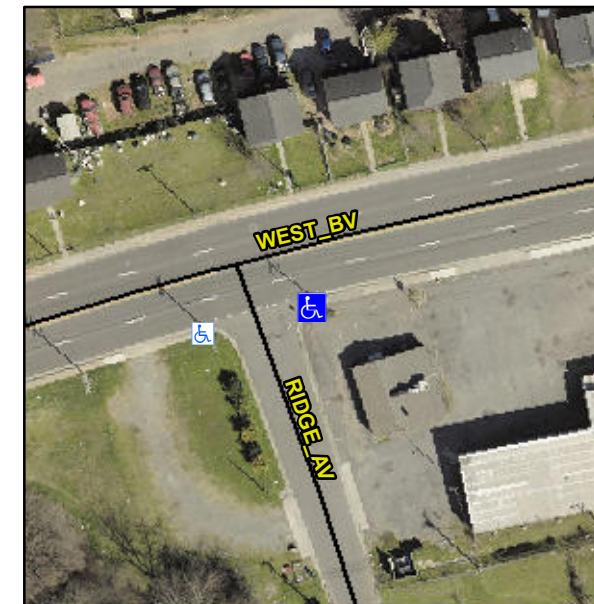
Not Found, R304.5.1, R304.5.3

Compliance	Description	Data	Compliance	Description	Data
N/A	Ramp Length (in)	52.0	Yes	Ramp Slope (%)	8.0
No	Ramp Width (in)	41.0	No	Ramp XSlope (%)	2.5
N/A	Flare Type LT	N/A	N/A	Flare Type RT	N/A
N/A	Flare Slope LT (%)	N/A	N/A	Flare Slope RT (%)	N/A
N/A	Flare Traversable LT?	N/A	N/A	Flare Traversable RT?	N/A
N/A	Landing Length (in)	N/A	N/A	DWS Provided?	N/A
N/A	Landing Width (in)	N/A	N/A	DWS Contrast?	N/A
N/A	Landing Slope (%)	N/A	N/A	DWS Length (in)	N/A
N/A	Landing X Slope (%)	N/A	N/A	DWS Full Width?	N/A
N/A	Landing Curb? (Y/N)	N/A	N/A	DWS Offset (in)	N/A
N/A	Shared Landing?	N/A			
N/A	Gutter Ponding?	N/A	N/A	Gutter Slope (%)	N/A
N/A	Gutter Lip Ht (in)	N/A	N/A	Gutter X Slope (%)	N/A
N/A	Painted X Walk1?	No	N/A	Painted X Walk2?	No
	X Walk 1 Direction	To N		X Walk 2 Direction	To W
N/A	X Walk 1 Width (in)	N/A	N/A	X Walk 2 Width (in)	N/A
	X Walk 1 Slope (%)	1.9		X Walk 2 Slope (%)	1.8
	X Walk 1 X Slope (%)	0.1		X Walk 2 X Slope (%)	1.2

N/A	Ramp inside XWalk1?	N/A	N/A	Ramp inside XWalk2?	N/A
	Road Slope (%)	3.5	N/A	Clear Space?	N/A
	Road X Slope (%)	5.0	N/A	Clear Space to XWalk (in)	N/A
N/A	Any Obstructions?	N/A	N/A	Storm Grate/Utility Hazard?	N/A
	Obstruction Type			Storm Grate/Utility Type	
		N/A			N/A
			Yes	Surface Condition? (G/P)	Good

Remove & Replace Curb Ramp With Two New Directional Ramps or Equivalent.
