Access Compliance Report

Public Rights-of-Way

(Curb Ramps)

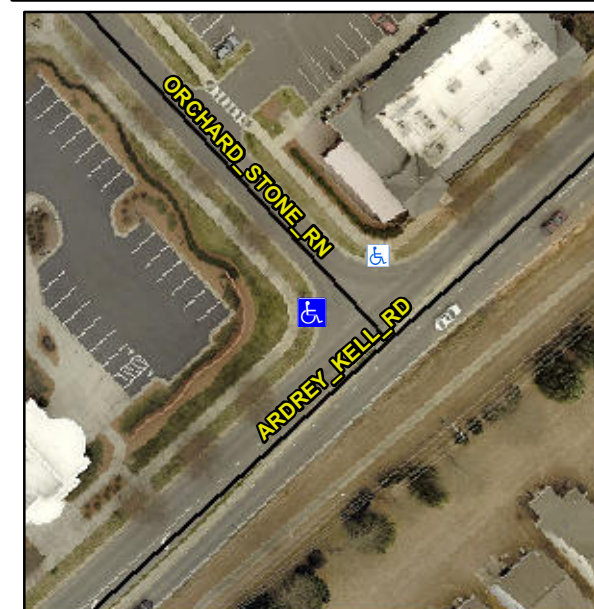
Intersection ID: 50233	Main Street: ORCHARD_STONE_RN	Cross Street: ARDREY_KELL_RD	Location: SW
ADA ID: 30DABD96F04F	Ramp Type: Perp	Initial Pass/Fail: Fail	Overall Compliance: No
Severity Score: 8.75			
Codes/Mitigation Info/Possible Solution		Field Measurements/Component Compliance

Not Found, R304.5.1

Compliance	Description	Data	Compliance	Description	Data
N/A	Ramp Length (in)	92.0	Yes	Ramp Slope (%)	6.6
No	Ramp Width (in)	46.0	Yes	Ramp XSlope (%)	0.2
N/A	Flare Type LT	N/A	N/A	Flare Type RT	N/A
N/A	Flare Slope LT (%)	N/A	N/A	Flare Slope RT (%)	N/A
N/A	Flare Traversable LT?	N/A	N/A	Flare Traversable RT?	N/A
N/A	Landing Length (in)	N/A	N/A	DWS Provided?	N/A
N/A	Landing Width (in)	N/A	N/A	DWS Contrast?	N/A
N/A	Landing Slope (%)	N/A	N/A	DWS Length (in)	N/A
N/A	Landing X Slope (%)	N/A	N/A	DWS Full Width?	N/A
N/A	Landing Curb? (Y/N)	N/A	N/A	DWS Offset (in)	N/A
N/A	Shared Landing?	N/A			
N/A	Gutter Ponding?	N/A	N/A	Gutter Slope (%)	N/A
N/A	Gutter Lip Ht (in)	N/A	N/A	Gutter X Slope (%)	N/A
N/A	Painted X Walk1?	No	N/A	Painted X Walk2?	N/A
	X Walk 1 Direction	To NE		X Walk 2 Direction	N/A
N/A	X Walk 1 Width (in)	N/A	N/A	X Walk 2 Width (in)	N/A
	X Walk 1 Slope (%)	0.0		X Walk 2 Slope (%)	N/A
	X Walk 1 X Slope (%)	2.0		X Walk 2 X Slope (%)	N/A

N/A	Ramp inside XWalk1?	N/A	N/A	Ramp inside XWalk2?	N/A
	Road Slope (%)	N/A	N/A	Clear Space?	N/A
	Road X Slope (%)	N/A	N/A	Clear Space to XWalk (in)	N/A
N/A	Any Obstructions?	N/A	N/A	Storm Grate/Utility Hazard?	N/A
	Obstruction Type			Storm Grate/Utility Type	
		N/A			N/A
		Yes		Surface Condition? (G/P)	Good

Remove & Replace Entire Ramp.

Total Cost: \$ 1850.00
