Access Compliance Report

Public Rights-of-Way

(Curb Ramps)

Intersection ID: 8706	Main Street: HALSEY_ST	Cross Street: ROZZELLES_FERRY_RD	Location: W
ADA ID: 30EA5419B4D2	Ramp Type: Combination1	Initial Pass/Fail: Fail	Overall Compliance: No
			Severity Score: 58.75

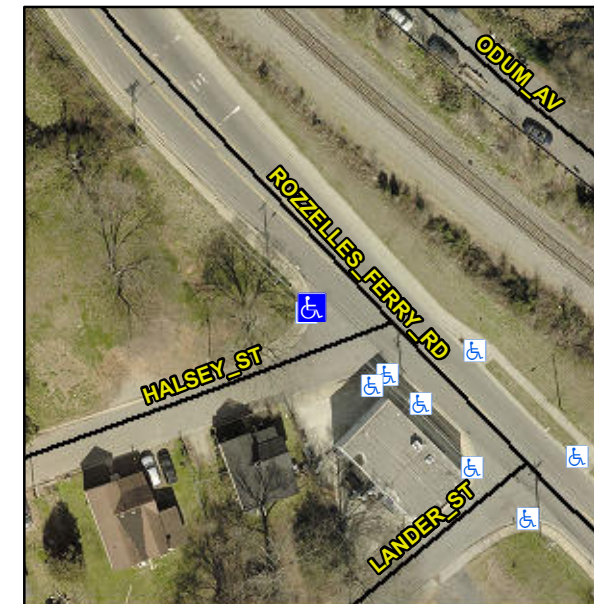
RP < 5%

**Not Found, R304.5.1, R304.5.1,
R304.5.3, R304.3.2**

Compliance	Description	Data	Compliance	Description	Data
N/A	Ramp Length LT (in)	60.0	N/A	Ramp Length RT (in)	64.0
No	Ramp Width LT (in)	42.0	Yes	Ramp Width RT (in)	60.0
No	Ramp Slope LT (%)	11.5	No	Ramp Slope RT (%)	12.3
No	Ramp XSlope LT (%)	5.2	Yes	Ramp XSlope RT (%)	1.0
N/A	Ramp Length (in)	60.0	Yes	Ramp Slope (%)	1.5
No	Ramp Width (in)	42.0	No	Ramp XSlope (%)	13.0
N/A	Flare Type LT	N/A	N/A	Flare Type RT	N/A
N/A	Flare Slope LT (%)	N/A	N/A	Flare Slope RT (%)	N/A
N/A	Flare Traversable LT?	N/A	N/A	Flare Traversable RT?	N/A
N/A	Landing Length (in)	N/A	N/A	DWS Provided?	N/A
N/A	Landing Width (in)	N/A	N/A	DWS Contrast?	N/A
N/A	Landing Slope (%)	N/A	N/A	DWS Length (in)	N/A
N/A	Landing X Slope (%)	N/A	N/A	DWS Full Width?	N/A
N/A	Landing Curb? (Y/N)	N/A	N/A	DWS Offset (in)	N/A
N/A	Shared Landing?	N/A			
N/A	Gutter Ponding?	N/A	N/A	Gutter Slope (%)	N/A
N/A	Gutter Lip Ht (in)	N/A	N/A	Gutter X Slope (%)	N/A
N/A	Painted X Walk1?	No	N/A	Painted X Walk2?	N/A

X Walk 1 Direction	To SE		X Walk 2 Direction	N/A
	X Walk 1 Width (in)	N/A		X Walk 2 Width (in)	N/A
	X Walk 1 Slope (%)	1.0		X Walk 2 Slope (%)	N/A
	X Walk 1 X Slope (%)	11.5		X Walk 2 X Slope (%)	N/A
N/A	Ramp inside XWalk1?	N/A	N/A	Ramp inside XWalk2?	N/A
	Road Slope (%)	N/A		Clear Space?	N/A
	Road X Slope (%)	N/A	N/A	Clear Space to XWalk (in)	N/A
			N/A	Any Obstruction?	N/A
				Obstruction Type	N/A
			N/A	Storm Grate/Utility Hazard?	N/A
				Storm Grate/Utility Type	N/A
			Yes	Surface Condition? (G/P)	Good
				Curb Slope (%)	16.7

Possible Solutions:

Remove & Replace Entire Ramp.
