# Access Compliance Report

## Public Rights-of-Way

### (Curb Ramps)

Intersection ID: 29237	Main Street: TESSERA_DR	Cross Street: WOODINGTON_LN	Location: NE
ADA ID: 30F01F2696C5	Ramp Type: BlendTrans1	Initial Pass/Fail: Fail	Overall Compliance: No
Severity Score: 10			
Codes/Mitigation Info/Possible Solution		Field Measurements/Component Compliance

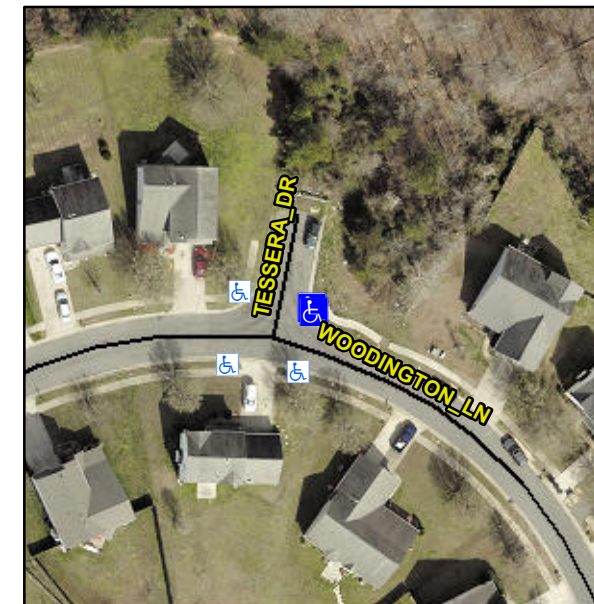
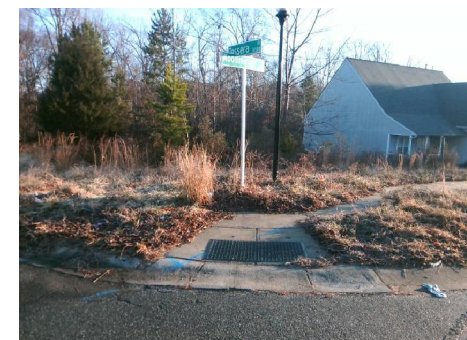
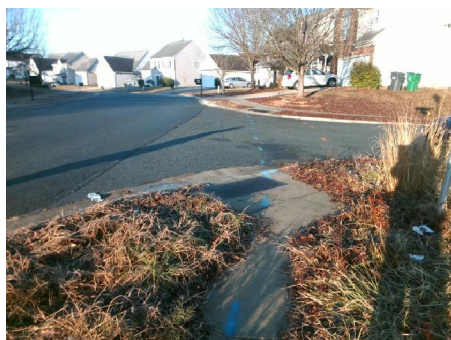
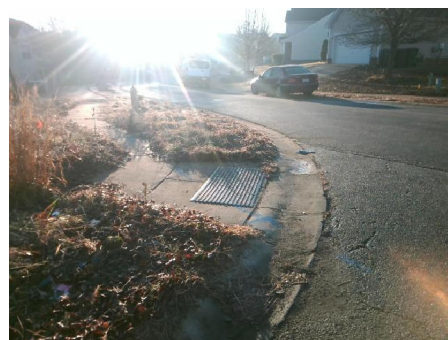
Compliance	Description	Data	Compliance	Description	Data
N/A	Ramp Length (in)	47.0	Yes	BlendTrans Slope (%)	1.2
No	Ramp Width (in)	45.0	No	BlendTrans XSlope (%)	2.2
N/A	Flare Type LT	N/A	N/A	Flare Type RT	N/A
N/A	Flare Slope LT (%)	N/A	N/A	Flare Slope RT (%)	N/A
N/A	Flare Traversable LT?	N/A	N/A	Flare Traversable RT?	N/A
N/A	Landing Length (in)	N/A	N/A	DWS Provided?	N/A
N/A	Landing Width (in)	N/A	N/A	DWS Contrast?	N/A
N/A	Landing Slope (%)	N/A	N/A	DWS Length (in)	N/A
N/A	Landing X Slope (%)	N/A	N/A	DWS Full Width?	N/A
N/A	Landing Curb? (Y/N)	N/A	N/A	DWS Offset (in)	N/A
N/A	Shared Landing?	N/A			
N/A	Gutter Ponding?	N/A	N/A	Gutter Slope (%)	N/A
N/A	Gutter Lip Ht (in)	N/A	N/A	Gutter X Slope (%)	N/A
N/A	Painted X Walk1?	No	N/A	Painted X Walk2?	No
	X Walk 1 Direction	To W		X Walk 2 Direction	To S
	X Walk 1 Width (in)	N/A		X Walk 2 Width (in)	N/A
	X Walk 1 Slope (%)	4.2		X Walk 2 Slope (%)	5.7
	X Walk 1 X Slope (%)	3.5		X Walk 2 X Slope (%)	2.7

N/A	Ramp inside XWalk1?	N/A	N/A	Ramp inside XWalk2?	N/A
	Road Slope (%)	0.7		Clear Space?	N/A
	Road X Slope (%)	4.2	N/A	Clear Space to XWalk (in)	N/A
N/A	Any Obstructions?	N/A	N/A	Storm Grate/Utility Hazard?	N/A
	Obstruction Type			Storm Grate/Utility Type	
		N/A			N/A
			Yes	Surface Condition? (G/P)	Good
			N/A	Curb Slope (%)	4.0

Possible Solutions:

**Remove & Replace Curb Ramp With Two New Directional Ramps or Equivalent.**

**R304.5.1, R304.5.3**
