Access Compliance Report

Public Rights-of-Way

(Curb Ramps)

Intersection ID: 16069	Main Street: BOWMAN_RD	Cross Street: S_TRYON_ST	Location: NW
ADA ID: 30F6805B8016	Ramp Type: PerpDiag	Initial Pass/Fail: Fail	Overall Compliance: No
Severity Score: 10			
Codes/Mitigation Info/Possible Solution		Field Measurements/Component Compliance

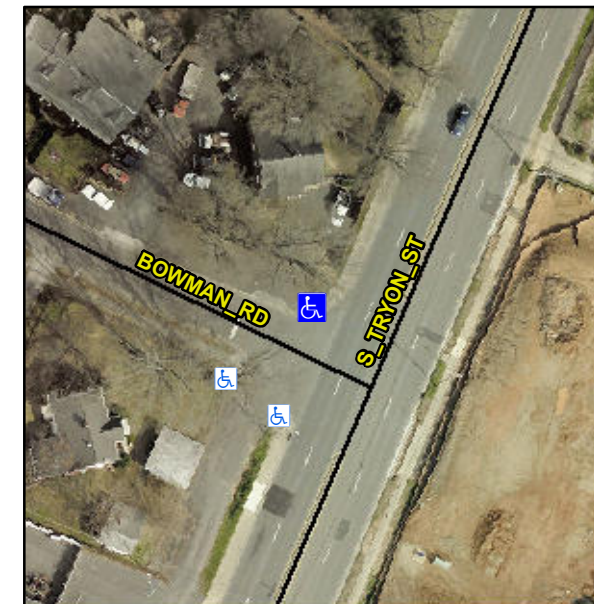
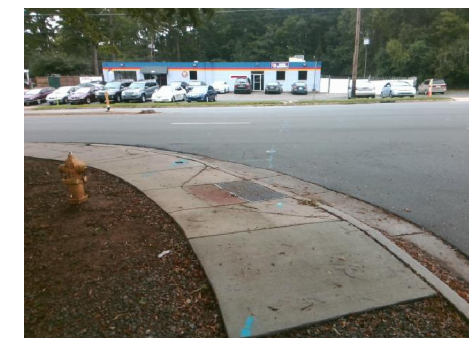
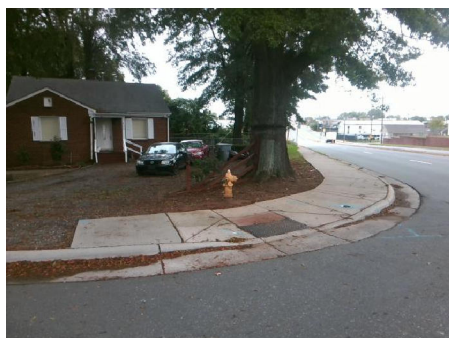
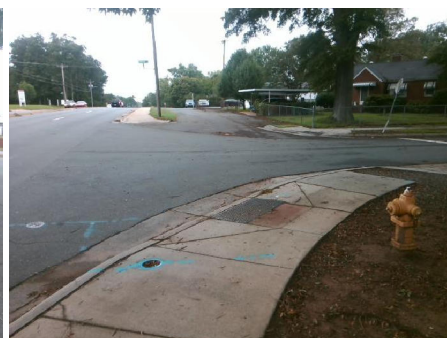
Compliance	Description	Data	Compliance	Description	Data
N/A	Ramp Length (in)	72.0	Yes	Ramp Slope (%)	7.7
No	Ramp Width (in)	44.0	No	Ramp XSlope (%)	4.4
N/A	Flare Type LT	N/A	N/A	Flare Type RT	N/A
N/A	Flare Slope LT (%)	N/A	N/A	Flare Slope RT (%)	N/A
N/A	Flare Traversable LT?	N/A	N/A	Flare Traversable RT?	N/A
N/A	Landing Length (in)	N/A	N/A	DWS Provided?	N/A
N/A	Landing Width (in)	N/A	N/A	DWS Contrast?	N/A
N/A	Landing Slope (%)	N/A	N/A	DWS Length (in)	N/A
N/A	Landing X Slope (%)	N/A	N/A	DWS Full Width?	N/A
N/A	Landing Curb? (Y/N)	N/A	N/A	DWS Offset (in)	N/A
N/A	Shared Landing?	N/A			
N/A	Gutter Ponding?	N/A	N/A	Gutter Slope (%)	N/A
N/A	Gutter Lip Ht (in)	N/A	N/A	Gutter X Slope (%)	N/A
N/A	Painted X Walk1?	No	N/A	Painted X Walk2?	No
	X Walk 1 Direction	To SW		X Walk 2 Direction	To SE
N/A	X Walk 1 Width (in)	N/A	N/A	X Walk 2 Width (in)	N/A
	X Walk 1 Slope (%)	5.2		X Walk 2 Slope (%)	5.8
	X Walk 1 X Slope (%)	0.1		X Walk 2 X Slope (%)	6.1

N/A	Ramp inside XWalk1?	N/A	N/A	Ramp inside XWalk2?	N/A
	Road Slope (%)	2.2	N/A	Clear Space?	N/A
	Road X Slope (%)	7.4	N/A	Clear Space to XWalk (in)	N/A
N/A	Any Obstructions?	N/A	N/A	Storm Grate/Utility Hazard?	N/A
	Obstruction Type			Storm Grate/Utility Type	
		N/A			N/A
			Yes	Surface Condition? (G/P)	Good

Possible Solutions:

Remove & Replace Curb Ramp With Two New Directional Ramps or Equivalent.

R304.5.1, R304.5.3
