# Access Compliance Report

## Public Rights-of-Way

### (Curb Ramps)

Intersection ID: 44446	Main Street: REAMES_RD	Cross Street: PRESTBURY_BV	Location: NW
ADA ID: 30FA5752CABD	Ramp Type: PerpDiag	Initial Pass/Fail: Fail	Overall Compliance: No
		Severity Score: 10

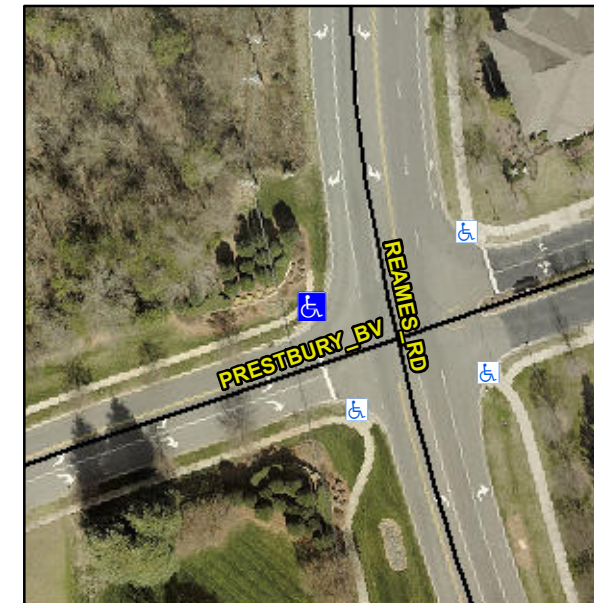
**Not Found, R304.5.1, R304.5.3**

Compliance	Description	Data	Compliance	Description	Data
N/A	Ramp Length (in)	71.5	Yes	Ramp Slope (%)	5.4
No	Ramp Width (in)	45.0	No	Ramp XSlope (%)	2.3
N/A	Flare Type LT	N/A	N/A	Flare Type RT	N/A
N/A	Flare Slope LT (%)	N/A	N/A	Flare Slope RT (%)	N/A
N/A	Flare Traversable LT?	N/A	N/A	Flare Traversable RT?	N/A
N/A	Landing Length (in)	N/A	N/A	DWS Provided?	N/A
N/A	Landing Width (in)	N/A	N/A	DWS Contrast?	N/A
N/A	Landing Slope (%)	N/A	N/A	DWS Length (in)	N/A
N/A	Landing X Slope (%)	N/A	N/A	DWS Full Width?	N/A
N/A	Landing Curb? (Y/N)	N/A	N/A	DWS Offset (in)	N/A
N/A	Shared Landing?	N/A			
N/A	Gutter Ponding?	N/A	N/A	Gutter Slope (%)	N/A
N/A	Gutter Lip Ht (in)	N/A	N/A	Gutter X Slope (%)	N/A
N/A	Painted X Walk1?	No	N/A	Painted X Walk2?	No
	X Walk 1 Direction	To S		X Walk 2 Direction	To E
N/A	X Walk 1 Width (in)	N/A	N/A	X Walk 2 Width (in)	N/A
	X Walk 1 Slope (%)	0.5		X Walk 2 Slope (%)	0.8
	X Walk 1 X Slope (%)	2.5		X Walk 2 X Slope (%)	0.5

N/A	Ramp inside XWalk1?	N/A	N/A	Ramp inside XWalk2?	N/A
	Road Slope (%)	2.4	N/A	Clear Space?	N/A
	Road X Slope (%)	2.1	N/A	Clear Space to XWalk (in)	N/A
N/A	Any Obstructions?	N/A	N/A	Storm Grate/Utility Hazard?	N/A
	Obstruction Type			Storm Grate/Utility Type	
		N/A			N/A
		Yes		Surface Condition? (G/P)	Good

**Remove & Replace Curb Ramp With Two New Directional Ramps or Equivalent.**
