# Access Compliance Report

## Public Rights-of-Way

### (Curb Ramps)

Intersection ID: 8213	Main Street: LYLES_CT	Cross Street: SPRINGVIEW_RD	Location: E
ADA ID: 30FACD37B02D	Ramp Type: Perp	Initial Pass/Fail: Fail	Overall Compliance: No
		Severity Score: 22.5

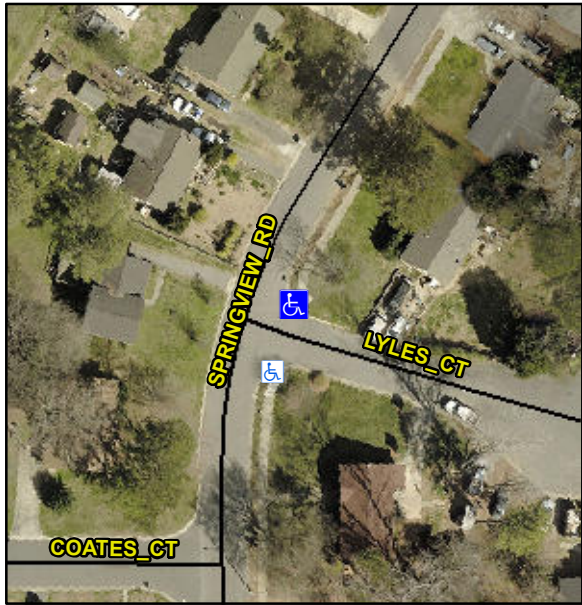
Possible Solutions:		Compliance	Description	Data	Compliance	Description	Data
	Remove & Replace Entire Ramp.		N/A	Ramp Length (in)	46.0	No	Ramp Slope (%)	10.7
			No	Ramp Width (in)	47.0	No	Ramp XSlope (%)	2.8
			N/A	Flare Type LT	N/A	N/A	Flare Type RT	N/A
			N/A	Flare Slope LT (%)	N/A	N/A	Flare Slope RT (%)	N/A
			N/A	Flare Traversable LT?	N/A	N/A	Flare Traversable RT?	N/A
			N/A	Landing Length (in)	N/A	N/A	DWS Provided?	N/A
			N/A	Landing Width (in)	N/A	N/A	DWS Contrast?	N/A
			N/A	Landing Slope (%)	N/A	N/A	DWS Length (in)	N/A
			N/A	Landing X Slope (%)	N/A	N/A	DWS Full Width?	N/A
Surveyor Notes:		N/A	N/A	Landing Curb? (Y/N)	N/A	N/A	DWS Offset (in)	N/A
PROW/ADA:		R304.5.1, R304.2.2, R304.5.3	N/A	Shared Landing?	N/A	N/A	Gutter Slope (%)	N/A
			N/A	Gutter Ponding?	N/A	N/A	Gutter X Slope (%)	N/A
			N/A	Gutter Lip Ht (in)	0.5	N/A	Painted X Walk2?	N/A

N/A	Painted X Walk1?	No	N/A	X Walk 2 Direction	N/A
				X Walk 1 Direction	To S		X Walk 2 Width (in)	N/A
			N/A	X Walk 1 Width (in)	N/A	N/A	X Walk 2 Slope (%)	N/A
				X Walk 1 Slope (%)	2.6		X Walk 2 X Slope (%)	N/A
				X Walk 1 X Slope (%)	5.3		Ramp inside XWalk2?	N/A
			N/A	Ramp inside XWalk1?	N/A	N/A	Clear Space?	N/A
				Road Slope (%)	N/A	N/A	Clear Space to XWalk (in)	N/A
				Road X Slope (%)	N/A	N/A	Storm Grate/Utility Hazard?	N/A
			N/A	Any Obstructions?	N/A	N/A	Storm Grate/Utility Type	
				Obstruction Type				
						N/A		N/A
						Yes	Surface Condition? (G/P)	Good
		</
