Access Compliance Report

Public Rights-of-Way

(Curb Ramps)

Intersection ID: 31562	Main Street: CROSS_ST	Cross Street: HEY_ROCK_CT	Location: SW
ADA ID: 30FDF4D6ECEE	Ramp Type: BlendTrans1	Initial Pass/Fail: Fail	Overall Compliance: No
		Severity Score: 8.75

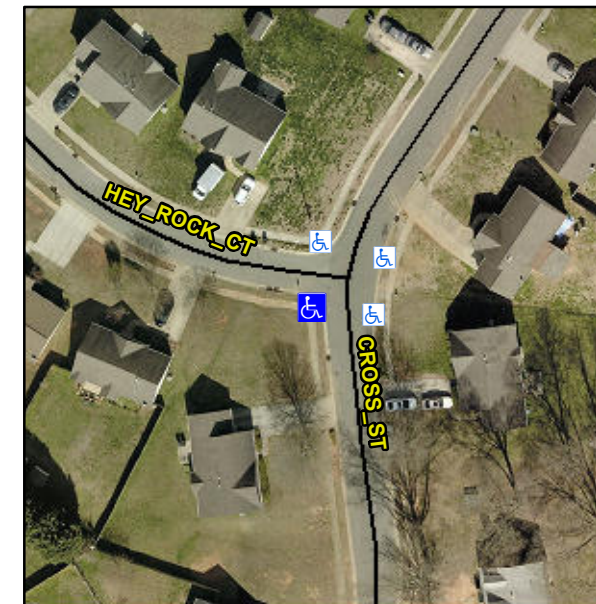
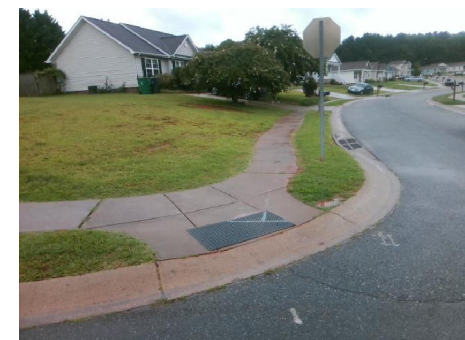
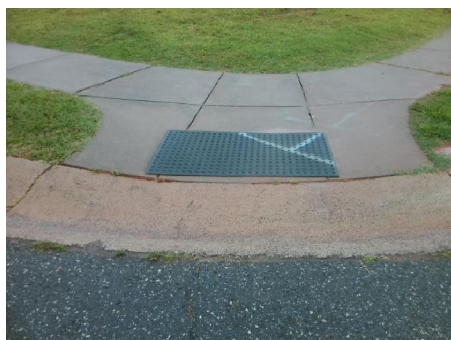
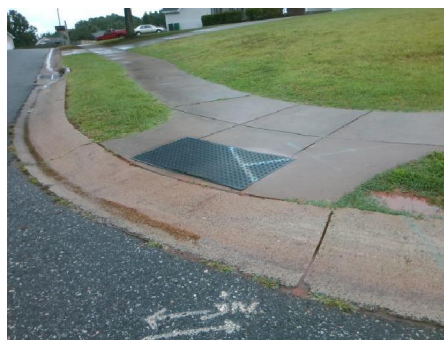
Not Found, R304.5.1

Compliance	Description	Data	Compliance	Description	Data
N/A	Ramp Length (in)	49.0	Yes	BlendTrans Slope (%)	3.9
No	Ramp Width (in)	38.0	Yes	BlendTrans XSlope (%)	1.8
N/A	Flare Type LT	N/A	N/A	Flare Type RT	N/A
N/A	Flare Slope LT (%)	N/A	N/A	Flare Slope RT (%)	N/A
N/A	Flare Traversable LT?	N/A	N/A	Flare Traversable RT?	N/A
N/A	Landing Length (in)	N/A	N/A	DWS Provided?	N/A
N/A	Landing Width (in)	N/A	N/A	DWS Contrast?	N/A
N/A	Landing Slope (%)	N/A	N/A	DWS Length (in)	N/A
N/A	Landing X Slope (%)	N/A	N/A	DWS Full Width?	N/A
N/A	Landing Curb? (Y/N)	N/A	N/A	DWS Offset (in)	N/A
N/A	Shared Landing?	N/A			
N/A	Gutter Ponding?	N/A	N/A	Gutter Slope (%)	N/A
N/A	Gutter Lip Ht (in)	N/A	N/A	Gutter X Slope (%)	N/A
N/A	Painted X Walk1?	No	N/A	Painted X Walk2?	No
	X Walk 1 Direction	To N		X Walk 2 Direction	To E
	X Walk 1 Width (in)	N/A		X Walk 2 Width (in)	N/A
	X Walk 1 Slope (%)	2.8		X Walk 2 Slope (%)	0.5
	X Walk 1 X Slope (%)	1.9		X Walk 2 X Slope (%)	0.2

N/A	Ramp inside XWalk1?	N/A	N/A	Ramp inside XWalk2?	N/A
	Road Slope (%)	1.3		Clear Space?	N/A
	Road X Slope (%)	0.8	N/A	Clear Space to XWalk (in)	N/A
N/A	Any Obstructions?	N/A	N/A	Storm Grate/Utility Hazard?	N/A
	Obstruction Type			Storm Grate/Utility Type	
		N/A			N/A
			Yes	Surface Condition? (G/P)	Good
			No	Curb Slope (%)	11.1

Remove & Replace Curb Ramp With Two New Directional Ramps or Equivalent.
