Access Compliance Report

Public Rights-of-Way

(Curb Ramps)

Intersection ID: 4511	Main Street: FRANK_VANCE_RD	Cross Street: PEPPER_ANN_LN	Location: NW
ADA ID: 310096324FE3	Ramp Type: Perp	Initial Pass/Fail: Fail	Overall Compliance: No
Severity Score: 12.5			
Codes/Mitigation Info/Possible Solution		Field Measurements/Component Compliance

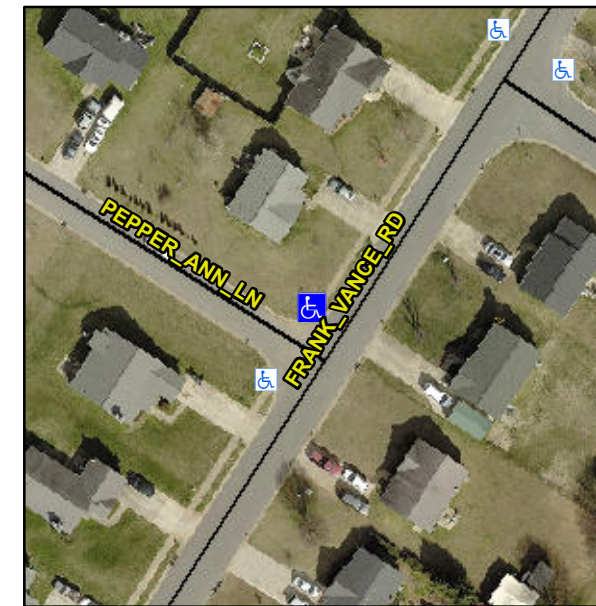
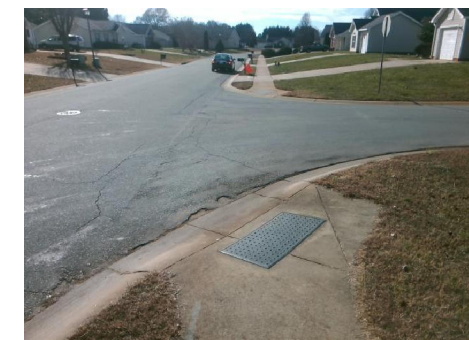
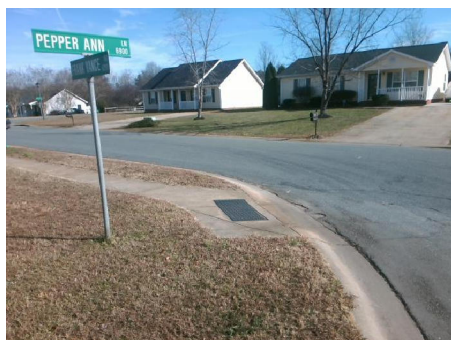
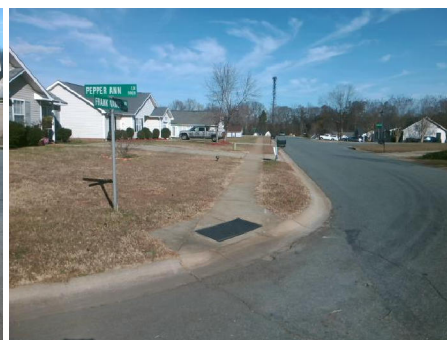
Not Found, R304.2.2

Compliance	Description	Data	Compliance	Description	Data
N/A	Ramp Length (in)	55.0	No	Ramp Slope (%)	9.8
Yes	Ramp Width (in)	48.0	Yes	Ramp XSlope (%)	0.3
N/A	Flare Type LT	N/A	N/A	Flare Type RT	N/A
N/A	Flare Slope LT (%)	N/A	N/A	Flare Slope RT (%)	N/A
N/A	Flare Traversable LT?	N/A	N/A	Flare Traversable RT?	N/A
N/A	Landing Length (in)	N/A	N/A	DWS Provided?	N/A
N/A	Landing Width (in)	N/A	N/A	DWS Contrast?	N/A
N/A	Landing Slope (%)	N/A	N/A	DWS Length (in)	N/A
N/A	Landing X Slope (%)	N/A	N/A	DWS Full Width?	N/A
N/A	Landing Curb? (Y/N)	N/A	N/A	DWS Offset (in)	N/A
N/A	Shared Landing?	N/A			
N/A	Gutter Ponding?	N/A	N/A	Gutter Slope (%)	N/A
N/A	Gutter Lip Ht (in)	0.8	N/A	Gutter X Slope (%)	N/A
N/A	Painted X Walk1?	No	N/A	Painted X Walk2?	N/A
	X Walk 1 Direction	To W		X Walk 2 Direction	N/A
N/A	X Walk 1 Width (in)	N/A	N/A	X Walk 2 Width (in)	N/A
	X Walk 1 Slope (%)	1.4		X Walk 2 Slope (%)	N/A
	X Walk 1 X Slope (%)	0.9		X Walk 2 X Slope (%)	N/A

N/A	Ramp inside XWalk1?	N/A	N/A	Ramp inside XWalk2?	N/A
	Road Slope (%)	N/A	N/A	Clear Space?	N/A
	Road X Slope (%)	N/A	N/A	Clear Space to XWalk (in)	N/A
N/A	Any Obstructions?	N/A	N/A	Storm Grate/Utility Hazard?	N/A
	Obstruction Type			Storm Grate/Utility Type	
		N/A			N/A
			Yes	Surface Condition? (G/P)	Good

Remove & Replace Entire Ramp.
