# Access Compliance Report

## Public Rights-of-Way

### (Curb Ramps)

Intersection ID: 9562	Main Street: CHESHIRE_AV	Cross Street: SANTEE_ST	Location:	N
ADA ID: 310116F23FCE	Ramp Type: Perp	Initial Pass/Fail: Fail	Overall Compliance: No	Severity Score: 26.25
Codes/Mitigation Info/Possible Solution		Field Measurements/Component Compliance

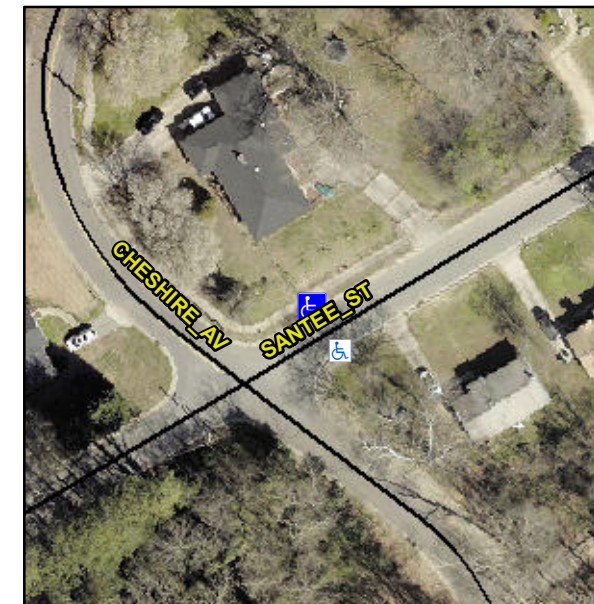
**Not Found, R304.2.2**

Compliance	Description	Data	Compliance	Description	Data
N/A	Ramp Length (in)	48.0	No	Ramp Slope (%)	13.9
Yes	Ramp Width (in)	48.0	Yes	Ramp XSlope (%)	3.3
N/A	Flare Type LT	N/A	N/A	Flare Type RT	N/A
N/A	Flare Slope LT (%)	N/A	N/A	Flare Slope RT (%)	N/A
N/A	Flare Traversable LT?	N/A	N/A	Flare Traversable RT?	N/A
N/A	Landing Length (in)	N/A	N/A	DWS Provided?	N/A
N/A	Landing Width (in)	N/A	N/A	DWS Contrast?	N/A
N/A	Landing Slope (%)	N/A	N/A	DWS Length (in)	N/A
N/A	Landing X Slope (%)	N/A	N/A	DWS Full Width?	N/A
N/A	Landing Curb? (Y/N)	N/A	N/A	DWS Offset (in)	N/A
N/A	Shared Landing?	N/A			
N/A	Gutter Ponding?	N/A	N/A	Gutter Slope (%)	N/A
N/A	Gutter Lip Ht (in)	N/A	N/A	Gutter X Slope (%)	N/A
N/A	Painted X Walk1?	No	N/A	Painted X Walk2?	N/A
	X Walk 1 Direction	To S		X Walk 2 Direction	N/A
N/A	X Walk 1 Width (in)	N/A	N/A	X Walk 2 Width (in)	N/A
	X Walk 1 Slope (%)	0.4		X Walk 2 Slope (%)	N/A
	X Walk 1 X Slope (%)	3.6		X Walk 2 X Slope (%)	N/A

Possible Solutions:

**Remove & Replace Entire Ramp.**

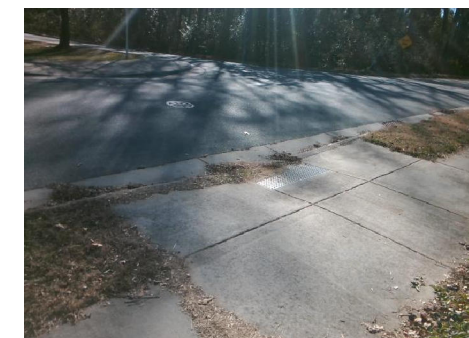
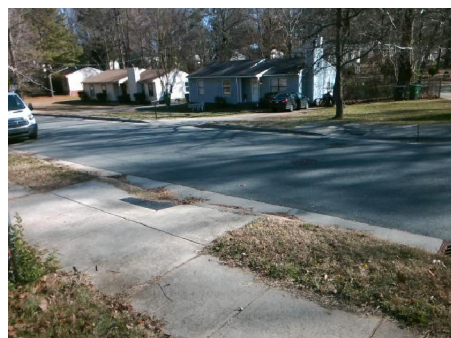
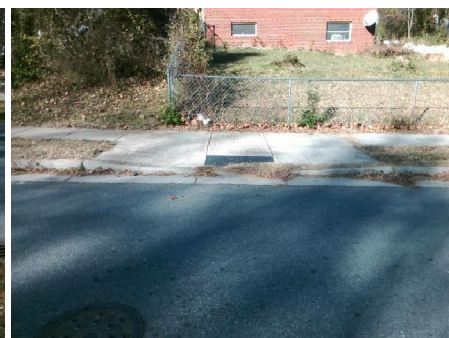
N/A	Ramp inside XWalk1?	N/A	N/A	Ramp inside XWalk2?	N/A
	Road Slope (%)	N/A	N/A	Clear Space?	N/A
	Road X Slope (%)	N/A	N/A	Clear Space to XWalk (in)	N/A
N/A	Any Obstructions?	N/A	N/A	Storm Grate/Utility Hazard?	N/A
	Obstruction Type			Storm Grate/Utility Type	
		N/A			N/A
			Yes	Surface Condition? (G/P)	Good
