# Access Compliance Report

## Public Rights-of-Way

### (Curb Ramps)

Intersection ID: 9703	Main Street: SHANNONHOUSE_DR	Cross Street: THE_PLAZA	Location: SE
ADA ID: 3101CA73790E	Ramp Type: Perp	Initial Pass/Fail: Fail	Overall Compliance: No
Severity Score: 21.25			
Codes/Mitigation Info/Possible Solution		Field Measurements/Component Compliance

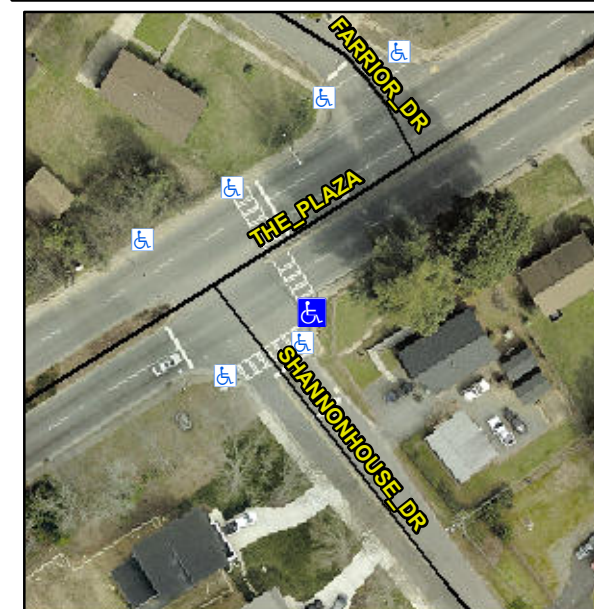
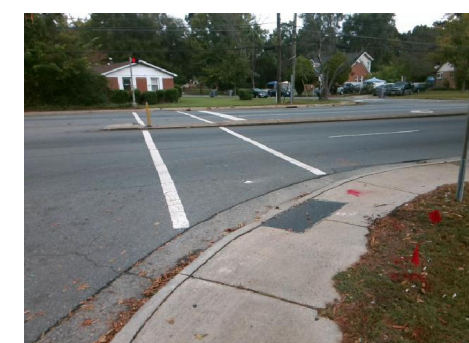
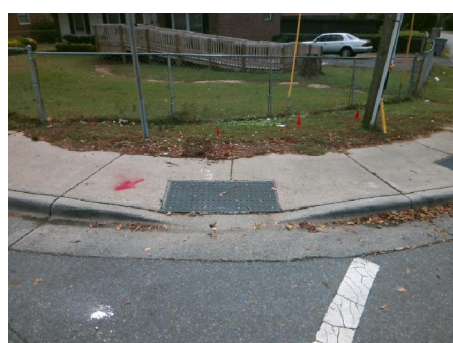
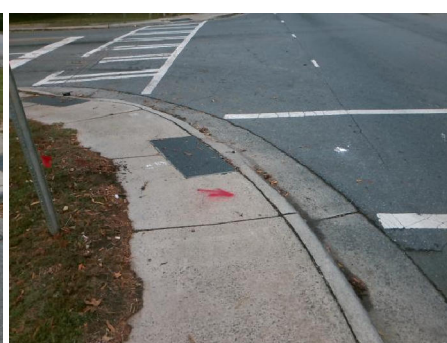
**Not Found, R304.5.1, R304.2.2**

Compliance	Description	Data	Compliance	Description	Data
N/A	Ramp Length (in)	61.0	No	Ramp Slope (%)	11.3
No	Ramp Width (in)	47.5	Yes	Ramp XSlope (%)	1.7
N/A	Flare Type LT	N/A	N/A	Flare Type RT	N/A
N/A	Flare Slope LT (%)	N/A	N/A	Flare Slope RT (%)	N/A
N/A	Flare Traversable LT?	N/A	N/A	Flare Traversable RT?	N/A
N/A	Landing Length (in)	N/A	N/A	DWS Provided?	N/A
N/A	Landing Width (in)	N/A	N/A	DWS Contrast?	N/A
N/A	Landing Slope (%)	N/A	N/A	DWS Length (in)	N/A
N/A	Landing X Slope (%)	N/A	N/A	DWS Full Width?	N/A
N/A	Landing Curb? (Y/N)	N/A	N/A	DWS Offset (in)	N/A
N/A	Shared Landing?	N/A			
N/A	Gutter Ponding?	N/A	N/A	Gutter Slope (%)	N/A
N/A	Gutter Lip Ht (in)	N/A	N/A	Gutter X Slope (%)	N/A
N/A	Painted X Walk1?	Yes	N/A	Painted X Walk2?	N/A
	X Walk 1 Direction	To NW		X Walk 2 Direction	N/A
N/A	X Walk 1 Width (in)	105.5	N/A	X Walk 2 Width (in)	N/A
	X Walk 1 Slope (%)	1.1		X Walk 2 Slope (%)	N/A
	X Walk 1 X Slope (%)	0.4		X Walk 2 X Slope (%)	N/A

N/A	Ramp inside XWalk1?	Yes	N/A	Ramp inside XWalk2?	N/A
	Road Slope (%)	N/A	N/A	Clear Space?	N/A
	Road X Slope (%)	N/A	N/A	Clear Space to XWalk (in)	N/A
N/A	Any Obstructions?	N/A	N/A	Storm Grate/Utility Hazard?	N/A
	Obstruction Type			Storm Grate/Utility Type	
		N/A			N/A
		Yes		Surface Condition? (G/P)	Good

**Remove & Replace Entire Ramp.**

Total Cost: \$ 1850.00
