Access Compliance Report

Public Rights-of-Way

(Curb Ramps)

| Intersection ID: 26585 | Main Street: ARBORHILL_RD | Cross Street: MANOR_HOUSE_DR | Location: SE |

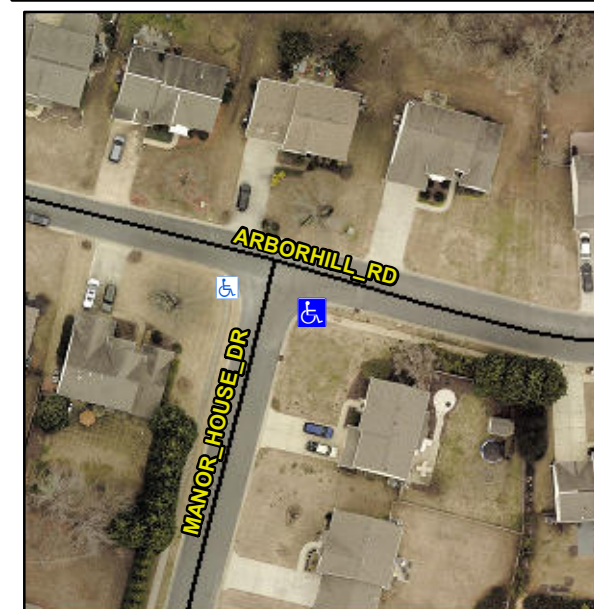
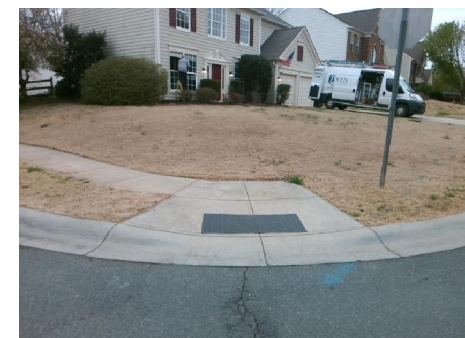
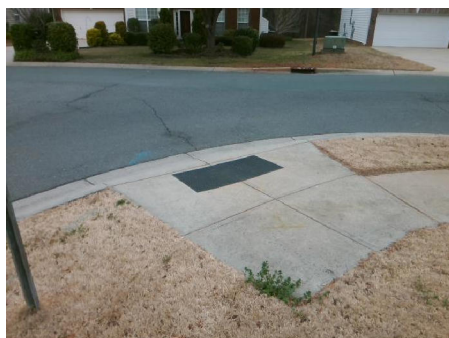
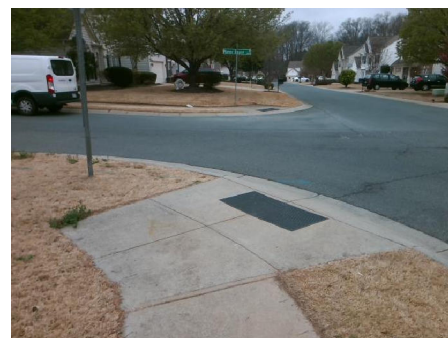
| ADA ID: 31048978691B | Ramp Type: BlendTrans1 | Initial Pass/Fail: Fail | Overall Compliance: No |
| Severity Score: 1.25 | | | |

Not Found, R304.5.3

| Compliance | Description | Data | Compliance | Description | Data |
|---|---|---|---|---|---|
| Yes | Ramp Width (in) | 48.0 | No | BlendTrans XSlope (%) | 2.8 |
| | | | No | Curb Slope (%) | 16.6 |

Remove & Replace Curb Ramp With Two New Directional Ramps or Equivalent.

Total Cost: \$ 3200.00
