Access Compliance Report

Public Rights-of-Way

(Curb Ramps)

Intersection ID: N/A	Main Street: NATIONS_FORD_RD	Cross Street: N/A	Location: N
ADA ID: 310AF371B3AC	Ramp Type: PerpDiag	Initial Pass/Fail: Fail	Overall Compliance: No
			Severity Score: 21.25

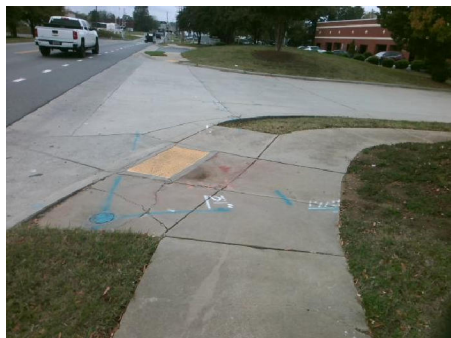
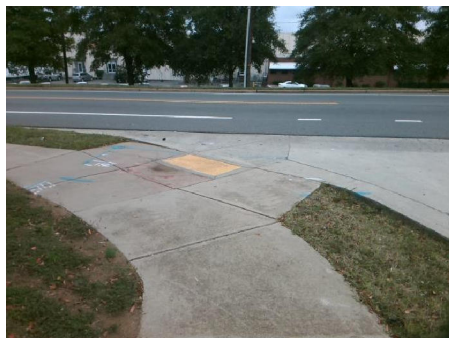
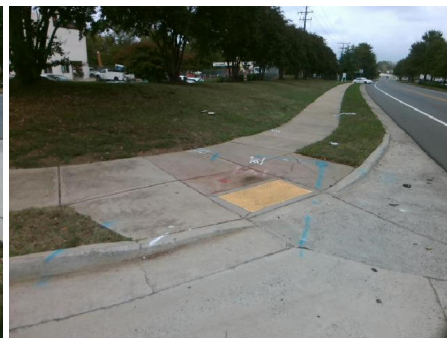
Compliance	Description	Data	Compliance	Description	Data
N/A	Ramp Length (in)	106.0	Yes	Ramp Slope (%)	7.2
No	Ramp Width (in)	45.0	No	Ramp XSlope (%)	6.3
N/A	Flare Type LT	N/A	N/A	Flare Type RT	N/A
N/A	Flare Slope LT (%)	N/A	N/A	Flare Slope RT (%)	N/A
N/A	Flare Traversable LT?	N/A	N/A	Flare Traversable RT?	N/A
N/A	Landing Length (in)	N/A	N/A	DWS Provided?	N/A
N/A	Landing Width (in)	N/A	N/A	DWS Contrast?	N/A
N/A	Landing Slope (%)	N/A	N/A	DWS Length (in)	N/A
N/A	Landing X Slope (%)	N/A	N/A	DWS Full Width?	N/A
N/A	Landing Curb? (Y/N)	N/A	N/A	DWS Offset (in)	N/A
N/A	Shared Landing?	N/A			
N/A	Gutter Ponding?	N/A	N/A	Gutter Slope (%)	N/A
N/A	Gutter Lip Ht (in)	N/A	N/A	Gutter X Slope (%)	N/A
N/A	Painted X Walk1?	No	N/A	Painted X Walk2?	No
	X Walk 1 Direction	To SW		X Walk 2 Direction	To SE
N/A	X Walk 1 Width (in)	N/A	N/A	X Walk 2 Width (in)	N/A
	X Walk 1 Slope (%)	0.4		X Walk 2 Slope (%)	3.6
	X Walk 1 X Slope (%)	2.0		X Walk 2 X Slope (%)	3.5

N/A	Ramp inside XWalk1?	N/A	N/A	Ramp inside XWalk2?	N/A
	Road Slope (%)	4.0	N/A	Clear Space?	N/A
	Road X Slope (%)	3.0	N/A	Clear Space to XWalk (in)	N/A
N/A	Any Obstructions?	N/A	N/A	Storm Grate/Utility Hazard?	N/A
	Obstruction Type			Storm Grate/Utility Type	
		N/A			N/A
			Yes	Surface Condition? (G/P)	Good

Remove & Replace Curb Ramp With Two New Directional Ramps or Equivalent.
