# Access Compliance Report

## Public Rights-of-Way

### (Curb Ramps)

Intersection ID: 10030374	Main Street: LEVINE AVENUE OF THE ARTS	Cross Street: N/A	Location: W
ADA ID: 3112E80C4B90	Ramp Type: Perp	Initial Pass/Fail: Fail	Overall Compliance: No
Severity Score: 12.5			
Codes/Mitigation Info/Possible Solution		Field Measurements/Component Compliance

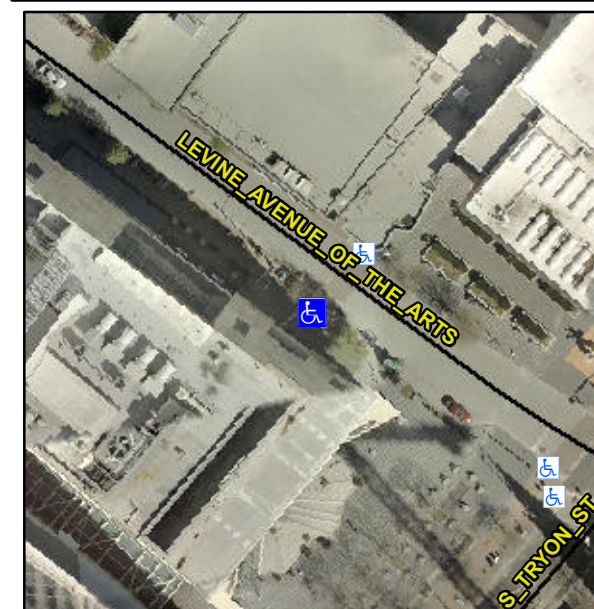
Compliance	Description	Data	Compliance	Description	Data
N/A	Ramp Length (in)	77.0	No	Ramp Slope (%)	9.0
Yes	Ramp Width (in)	60.0	Yes	Ramp XSlope (%)	1.3
N/A	Flare Type LT	N/A	N/A	Flare Type RT	N/A
N/A	Flare Slope LT (%)	N/A	N/A	Flare Slope RT (%)	N/A
N/A	Flare Traversable LT?	N/A	N/A	Flare Traversable RT?	N/A
N/A	Landing Length (in)	N/A	N/A	DWS Provided?	N/A
N/A	Landing Width (in)	N/A	N/A	DWS Contrast?	N/A
N/A	Landing Slope (%)	N/A	N/A	DWS Length (in)	N/A
N/A	Landing X Slope (%)	N/A	N/A	DWS Full Width?	N/A
N/A	Landing Curb? (Y/N)	N/A	N/A	DWS Offset (in)	N/A
N/A	Shared Landing?	N/A			
N/A	Gutter Ponding?	N/A	N/A	Gutter Slope (%)	N/A
N/A	Gutter Lip Ht (in)	N/A	N/A	Gutter X Slope (%)	N/A
N/A	Painted X Walk1?	Yes	N/A	Painted X Walk2?	N/A
	X Walk 1 Direction	To NE		X Walk 2 Direction	N/A
N/A	X Walk 1 Width (in)	147.0	N/A	X Walk 2 Width (in)	N/A
	X Walk 1 Slope (%)	2.2		X Walk 2 Slope (%)	N/A
	X Walk 1 X Slope (%)	2.3		X Walk 2 X Slope (%)	N/A

N/A	Ramp inside XWalk1?	Yes	N/A	Ramp inside XWalk2?	N/A
	Road Slope (%)	N/A	N/A	Clear Space?	N/A
	Road X Slope (%)	N/A	N/A	Clear Space to XWalk (in)	N/A
N/A	Any Obstructions?	N/A	N/A	Storm Grate/Utility Hazard?	N/A
	Obstruction Type			Storm Grate/Utility Type	
		N/A			N/A
		Yes		Surface Condition? (G/P)	Good

Possible Solutions:

**Remove & Replace Entire Ramp.**

**R304.2.2**

**\$ 1850.00**
