| Intersection ID: 18794 | Main Street: RANDOLPH_RD | Cross Street: REMBRANDT_CR | Location: | SW |
| ADA ID: 3118731EC6E3 | Ramp Type: PerpDiag | Initial Pass/Fail: Fail | Overall Compliance: No | Severity Score: 58.75 |

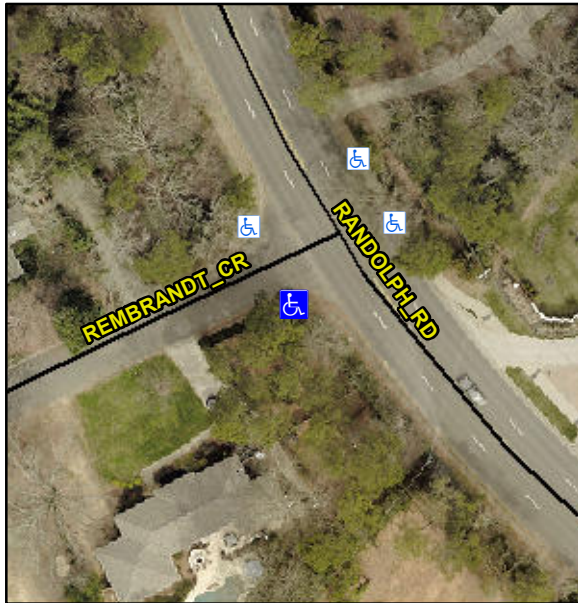
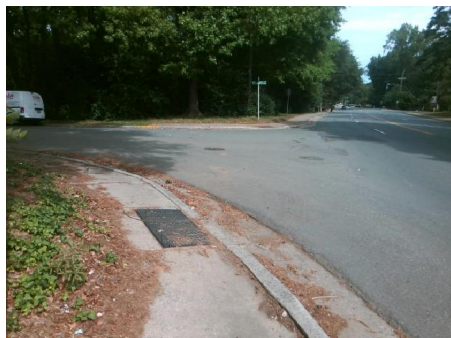
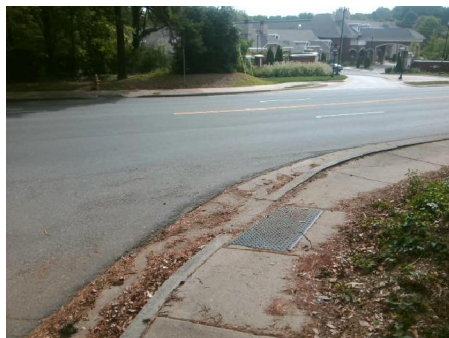
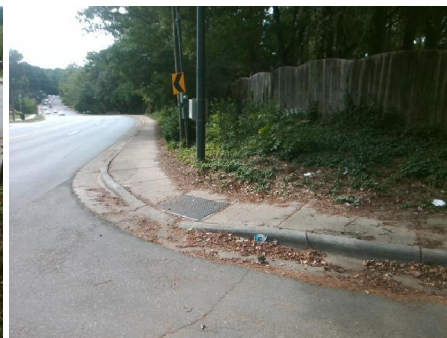
**Not Found, R304.5.1, R304.2.2,  
R304.5.3**

| Compliance | Description | Data | Compliance | Description | Data |
|---|---|---|---|---|---|
| N/A | Ramp Length (in) | 56.0 | No | Ramp Slope (%) | 16.2 |
| No | Ramp Width (in) | 47.0 | No | Ramp XSlope (%) | 10.3 |

**Remove & Replace Curb Ramp With Two New Directional Ramps or Equivalent.**
