# Access Compliance Report

## Public Rights-of-Way

### (Curb Ramps)

Intersection ID: 3907	Main Street: ALNWICK_CT	Cross Street: COPPERPLATE_RD	Location:	N
ADA ID: 311F2155B2B4	Ramp Type: Perp	Initial Pass/Fail: Fail	Overall Compliance: No	Severity Score: 1.25
Codes/Mitigation Info/Possible Solution		Field Measurements/Component Compliance

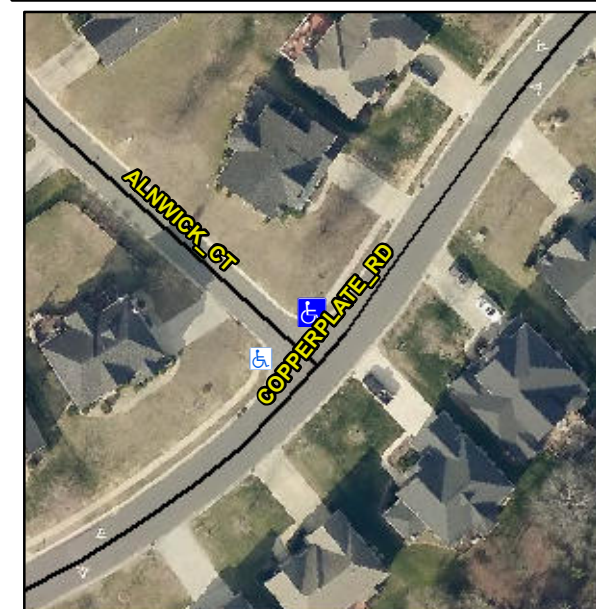
**Not Found, R304.5.3**

Compliance	Description	Data	Compliance	Description	Data
N/A	Ramp Length (in)	47.0	Yes	Ramp Slope (%)	7.0
Yes	Ramp Width (in)	48.0	No	Ramp XSlope (%)	3.3
N/A	Flare Type LT	N/A	N/A	Flare Type RT	N/A
N/A	Flare Slope LT (%)	N/A	N/A	Flare Slope RT (%)	N/A
N/A	Flare Traversable LT?	N/A	N/A	Flare Traversable RT?	N/A
N/A	Landing Length (in)	N/A	N/A	DWS Provided?	N/A
N/A	Landing Width (in)	N/A	N/A	DWS Contrast?	N/A
N/A	Landing Slope (%)	N/A	N/A	DWS Length (in)	N/A
N/A	Landing X Slope (%)	N/A	N/A	DWS Full Width?	N/A
N/A	Landing Curb? (Y/N)	N/A	N/A	DWS Offset (in)	N/A
N/A	Shared Landing?	N/A			
N/A	Gutter Ponding?	N/A	N/A	Gutter Slope (%)	N/A
N/A	Gutter Lip Ht (in)	N/A	N/A	Gutter X Slope (%)	N/A
N/A	Painted X Walk1?	No	N/A	Painted X Walk2?	N/A
	X Walk 1 Direction	To SW		X Walk 2 Direction	N/A
N/A	X Walk 1 Width (in)	N/A	N/A	X Walk 2 Width (in)	N/A
	X Walk 1 Slope (%)	0.4		X Walk 2 Slope (%)	N/A
	X Walk 1 X Slope (%)	1.7		X Walk 2 X Slope (%)	N/A

N/A	Ramp inside XWalk1?	N/A	N/A	Ramp inside XWalk2?	N/A
	Road Slope (%)	N/A	N/A	Clear Space?	N/A
	Road X Slope (%)	N/A	N/A	Clear Space to XWalk (in)	N/A
N/A	Any Obstructions?	N/A	N/A	Storm Grate/Utility Hazard?	N/A
	Obstruction Type			Storm Grate/Utility Type	
		N/A			N/A
			Yes	Surface Condition? (G/P)	Good

Possible Solutions:

**Remove & Replace Entire Ramp.**

Total Cost: \$ 1850.00
