Access Compliance Report

Public Rights-of-Way

(Curb Ramps)

Intersection ID: 45739	Main Street: REDWOOD VALLEY LN	Cross Street: PACIFIC ECHO DR	Location: SW
ADA ID: 31220CC9472E	Ramp Type: PerpDiag	Initial Pass/Fail: Fail	Overall Compliance: No
Severity Score: 21.25			
Codes/Mitigation Info/Possible Solution		Field Measurements/Component Compliance

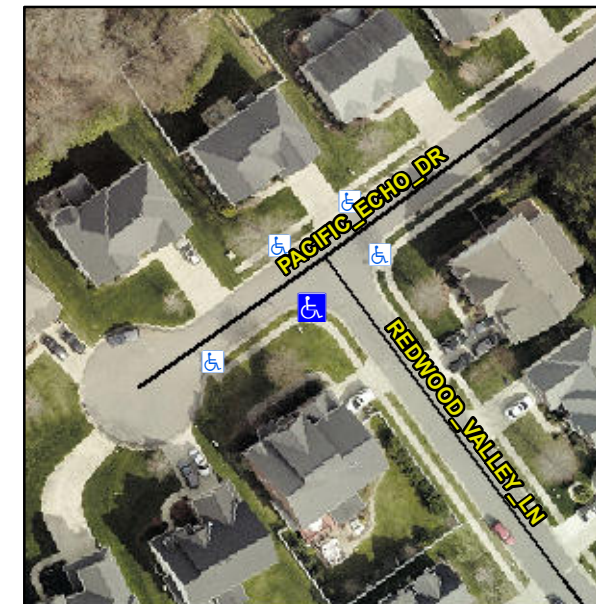
Not Found, R304.5.1, R304.5.3

Compliance	Description	Data	Compliance	Description	Data
N/A	Ramp Length (in)	50.0	Yes	Ramp Slope (%)	7.3
No	Ramp Width (in)	45.0	No	Ramp XSlope (%)	5.1
N/A	Flare Type LT	N/A	N/A	Flare Type RT	N/A
N/A	Flare Slope LT (%)	N/A	N/A	Flare Slope RT (%)	N/A
N/A	Flare Traversable LT?	N/A	N/A	Flare Traversable RT?	N/A
N/A	Landing Length (in)	N/A	N/A	DWS Provided?	N/A
N/A	Landing Width (in)	N/A	N/A	DWS Contrast?	N/A
N/A	Landing Slope (%)	N/A	N/A	DWS Length (in)	N/A
N/A	Landing X Slope (%)	N/A	N/A	DWS Full Width?	N/A
N/A	Landing Curb? (Y/N)	N/A	N/A	DWS Offset (in)	N/A
N/A	Shared Landing?	N/A			
N/A	Gutter Ponding?	N/A	N/A	Gutter Slope (%)	N/A
N/A	Gutter Lip Ht (in)	N/A	N/A	Gutter X Slope (%)	N/A
N/A	Painted X Walk1?	No	N/A	Painted X Walk2?	No
	X Walk 1 Direction	To NE		X Walk 2 Direction	To N
N/A	X Walk 1 Width (in)	N/A	N/A	X Walk 2 Width (in)	N/A
	X Walk 1 Slope (%)	7.6		X Walk 2 Slope (%)	0.5
	X Walk 1 X Slope (%)	1.2		X Walk 2 X Slope (%)	7.8

N/A	Ramp inside XWalk1?	N/A	N/A	Ramp inside XWalk2?	N/A
	Road Slope (%)	4.1	N/A	Clear Space?	N/A
	Road X Slope (%)	4.2	N/A	Clear Space to XWalk (in)	N/A
N/A	Any Obstructions?	N/A	N/A	Storm Grate/Utility Hazard?	N/A
	Obstruction Type			Storm Grate/Utility Type	
		N/A			N/A
			Yes	Surface Condition? (G/P)	Good

Possible Solutions:

Remove & Replace Curb Ramp With Two New Directional Ramps or Equivalent.
