Access Compliance Report

Public Rights-of-Way

(Curb Ramps)

Intersection ID: 13579	Main Street: S_MCDOWELL_ST	Cross Street: E_STONEWALL_ST	Location: NW
ADA ID: 312BD057CCB3	Ramp Type: Combination1	Initial Pass/Fail: Fail	Overall Compliance: No
		Severity Score: 12.5

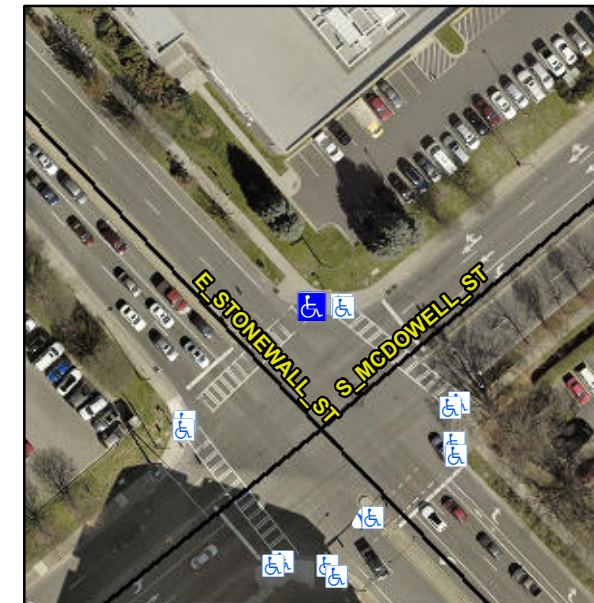
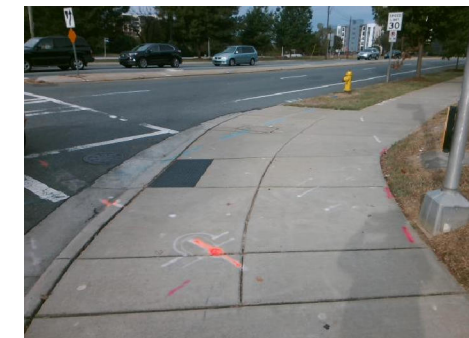
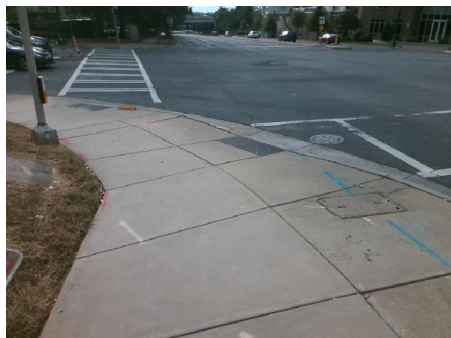
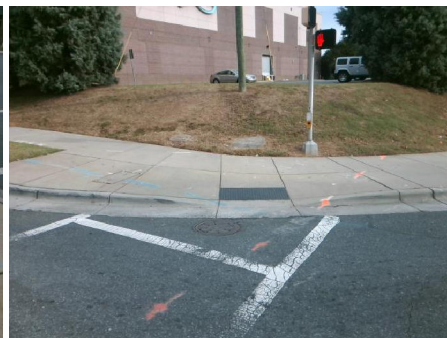
RT RP < 5%

Not Found, R304.5.3

Compliance	Description	Data	Compliance	Description	Data
N/A	Ramp Length LT (in)	148.0	N/A	Ramp Length RT (in)	54.0
Yes	Ramp Width LT (in)	62.0	Yes	Ramp Width RT (in)	60.0
Yes	Ramp Slope LT (%)	5.2	Yes	Ramp Slope RT (%)	1.0
Yes	Ramp XSlope LT (%)	0.9	No	Ramp XSlope RT (%)	2.3
N/A	Ramp Length (in)	119.0	Yes	Ramp Slope (%)	6.1
Yes	Ramp Width (in)	49.0	No	Ramp XSlope (%)	5.4
N/A	Flare Type LT	N/A	N/A	Flare Type RT	N/A
N/A	Flare Slope LT (%)	N/A	N/A	Flare Slope RT (%)	N/A
N/A	Flare Traversable LT?	N/A	N/A	Flare Traversable RT?	N/A
N/A	Landing Length (in)	N/A	N/A	DWS Provided?	N/A
N/A	Landing Width (in)	N/A	N/A	DWS Contrast?	N/A
N/A	Landing Slope (%)	N/A	N/A	DWS Length (in)	N/A
N/A	Landing X Slope (%)	N/A	N/A	DWS Full Width?	N/A
N/A	Landing Curb? (Y/N)	N/A	N/A	DWS Offset (in)	N/A
N/A	Shared Landing?	N/A			
N/A	Gutter Ponding?	N/A	N/A	Gutter Slope (%)	N/A
N/A	Gutter Lip Ht (in)	N/A	N/A	Gutter X Slope (%)	N/A
N/A	Painted X Walk1?	Yes	N/A	Painted X Walk2?	N/A

X Walk 1 Direction	To SW		X Walk 2 Direction	N/A
	X Walk 1 Width (in)	120.0		X Walk 2 Width (in)	N/A
	X Walk 1 Slope (%)	4.7		X Walk 2 Slope (%)	N/A
	X Walk 1 X Slope (%)	0.7		X Walk 2 X Slope (%)	N/A
N/A	Ramp inside XWalk1?	Yes	N/A	Ramp inside XWalk2?	N/A
	Road Slope (%)	N/A		Clear Space?	N/A
	Road X Slope (%)	N/A	N/A	Clear Space to XWalk (in)	N/A
			N/A	Any Obstruction?	N/A
				Obstruction Type	N/A
			N/A	Storm Grate/Utility Hazard?	N/A
				Storm Grate/Utility Type	N/A
Yes	Surface Condition? (G/P)	Good			
	Curb Slope (%)	12.2

Remove & Replace Entire Ramp.
