Access Compliance Report Public Rights-of-Way (Curb Ramps)

Intersection ID: 27040 Main Street: PIPER GLEN DR **Cross Street: REA RD** Location: NW ADA ID: 31311FA263A0 Ramp Type: Directional1 Initial Pass/Fail: Pass **Overall Compliance: Yes Severity Score:** 0

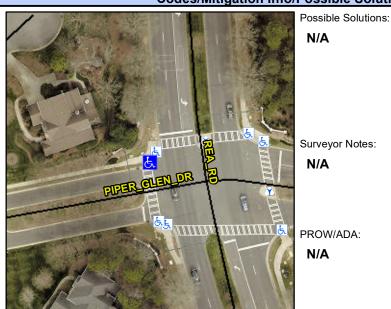
number Description				Dutt
/ A	Ramp Length (in)	44.0	Yes	Grade Break?	Yes
es	Ramp Width (in)	69.0	Yes	Grade Break Slope (%)	3.1
es	Ramp Slope (%)	2.3	Yes	Grade Break XSlope (%)	0.1
es	Ramp XSlope (%)	0.3			
es	Flare Type LT	N/A	Yes	Flare Type RT	N/A
/ A	Flare Slope LT (%)	N/A	N/A	Flare Slope RT (%)	N/A
/ A	Flare Traversable LT?	No	N/A	Flare Traversable RT?	No
es	Landing Length (in)	72.0	Yes	DWS Provided?	Yes
es	Landing Width (in)	56.0	Yes	DWS Contrast?	Yes
es	Landing Slope (%)	0.3	Yes	DWS Length (in)	24.0
es	Landing X Slope (%)	0.3	Yes	DWS Full Width?	Yes
/A	Landing Curb? (Y/N)	No	Yes	DWS Offset LT (in)	6.0
/ A	Shared Landing?	No	Yes	DWS Offset RT (in)	0.0
es	Gutter Ponding?	No	Yes	Gutter Slope (%)	4.1
es	Gutter Lip Ht (in)	0.0	Yes	Gutter X Slope (%)	1.4
/ A	Painted X Walk1?	Yes		Road Slope (%)	3.3
	X Walk 1 Direction	To SE		Road X Slope (%)	1.2
	X Walk 1 Width (in)	125.0		Clear Space?	Yes
	X Walk 1 Slope (%)	3.3	N/A	Clear Space to XWalk (in)	N/A

X Walk 1 X Slope (%)	1.2	Yes	Storm Grate/Utility Hazard?	No
es	Ramp inside XWalk1?	Yes		Storm Grate/Utility Type	
es	Any Obstructions?	No			N/A
	Obstruction Type		Yes	Surface Condition? (G/P)	Good
		N/A	Yes	Curb Slope (%)	1.8
