Access Compliance Report

Public Rights-of-Way (Curb Ramps)

Intersection ID: N/A	Main Street: HARDING_PL	Cross Street: N/A	Location: SE
ADA ID: 31458A3B1DD1	Ramp Type: PerpDiag	Initial Pass/Fail: Fail	Overall Compliance: No
Severity Score: 72.5			
Codes/Mitigation Info/Possible Solution		Field Measurements/Component Compliance

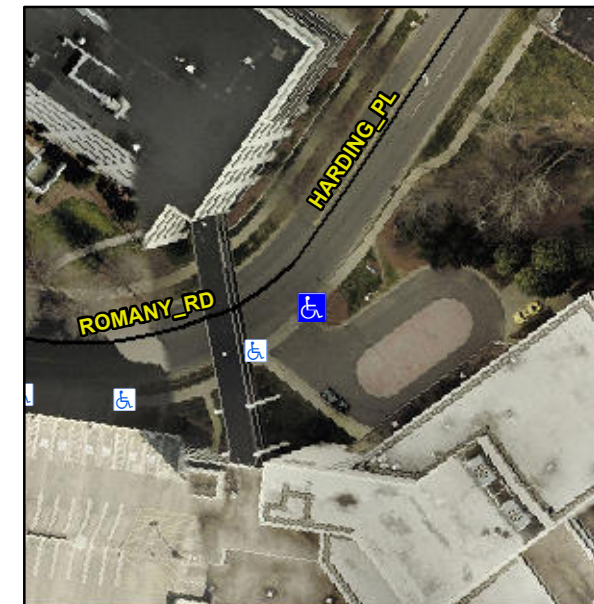
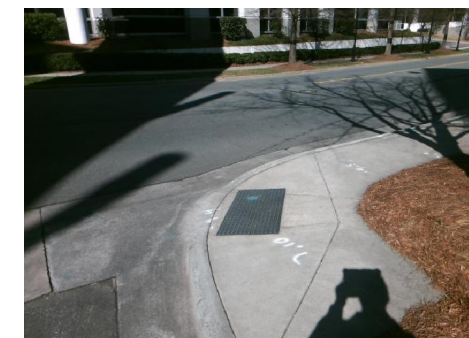
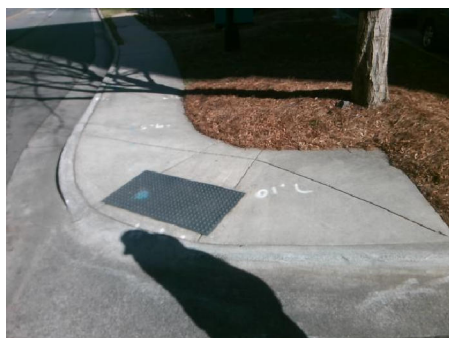
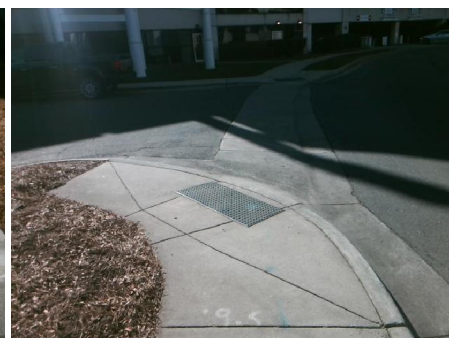
Not Found, R304.5.1, R304.2.2, R304.5.3

Compliance	Description	Data	Compliance	Description	Data
N/A	Ramp Length (in)	61.0	No	Ramp Slope (%)	9.2
No	Ramp Width (in)	25.0	No	Ramp XSlope (%)	7.1
N/A	Flare Type LT	N/A	N/A	Flare Type RT	N/A
N/A	Flare Slope LT (%)	N/A	N/A	Flare Slope RT (%)	N/A
N/A	Flare Traversable LT?	N/A	N/A	Flare Traversable RT?	N/A
N/A	Landing Length (in)	N/A	N/A	DWS Provided?	N/A
N/A	Landing Width (in)	N/A	N/A	DWS Contrast?	N/A
N/A	Landing Slope (%)	N/A	N/A	DWS Length (in)	N/A
N/A	Landing X Slope (%)	N/A	N/A	DWS Full Width?	N/A
N/A	Landing Curb? (Y/N)	N/A	N/A	DWS Offset (in)	N/A
N/A	Shared Landing?	N/A			
N/A	Gutter Ponding?	N/A	N/A	Gutter Slope (%)	N/A
N/A	Gutter Lip Ht (in)	N/A	N/A	Gutter X Slope (%)	N/A
N/A	Painted X Walk1?	No	N/A	Painted X Walk2?	No
	X Walk 1 Direction	To NE		X Walk 2 Direction	To NW
N/A	X Walk 1 Width (in)	N/A	N/A	X Walk 2 Width (in)	N/A
	X Walk 1 Slope (%)	5.0		X Walk 2 Slope (%)	4.5
	X Walk 1 X Slope (%)	4.8		X Walk 2 X Slope (%)	6.8

N/A	Ramp inside XWalk1?	N/A	N/A	Ramp inside XWalk2?	N/A
	Road Slope (%)	5.4	N/A	Clear Space?	N/A
	Road X Slope (%)	0.2	N/A	Clear Space to XWalk (in)	N/A
N/A	Any Obstructions?	N/A	N/A	Storm Grate/Utility Hazard?	N/A
	Obstruction Type			Storm Grate/Utility Type	
		N/A			N/A
			Yes	Surface Condition? (G/P)	Good

Remove & Replace Curb Ramp With Two New Directional Ramps or Equivalent.

Total Cost: \$ 3200.00
